SandVA

INSPECTION & ANALYSIS OF SAND CONTROL IN GAS STORAGE WELLS

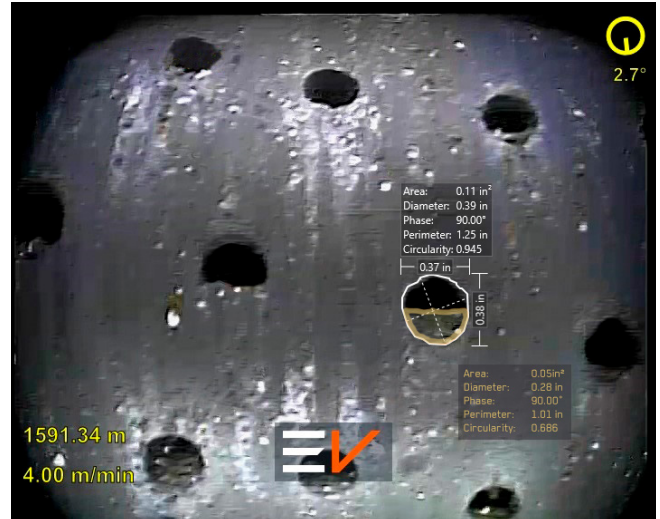
Figure 2: Dimensioned Base Holes Image

Following the visual assessment, individual base holes were then dimensioned at selected depths and azimuths (**fig.2**). As the well was near vertical over the sand screens the azimuth of measured holes were assigned to 90° sectors based on visual indications of the low side of the wellbore such as debris movement and tool string decentralization. 54% of the base holes were partially restricted (plugged) with debris having a sand-like appearance. **Fig.4** reveals a trend that emerged of increasing restricted flow area from the top to the bottom of the screen.

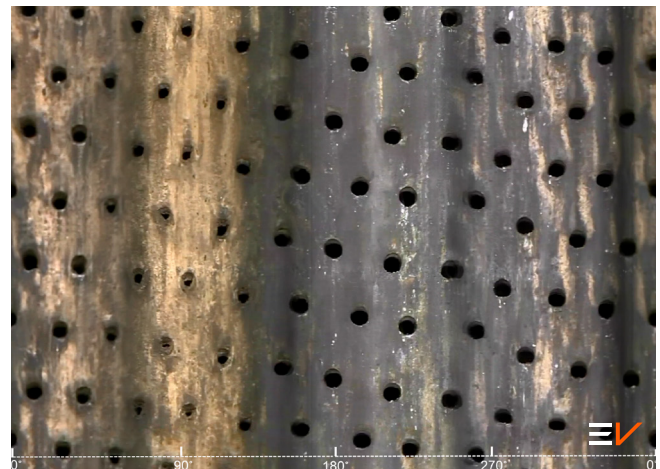
Figure 3: Processed 'Mosaic' Image

Mosaic images for each screen interval were created to provide an optimal medium for visual inspection of more than 2,500 base holes present in each assembly. Zones of specific interest can be quickly identified from such images as changes in pattern, hue and light intensity are easily identified. **Fig.2** provides an example of a 20cm interval near the top of the screen. This shows a deposit of sand like material on the tubular wall, along with partially plugged base holes particularly around the 90° azimuth. There was no visual evidence of erosion, however a trend of increasing restricted flow area emerged from the top to bottom of the screen (**Fig.4**).

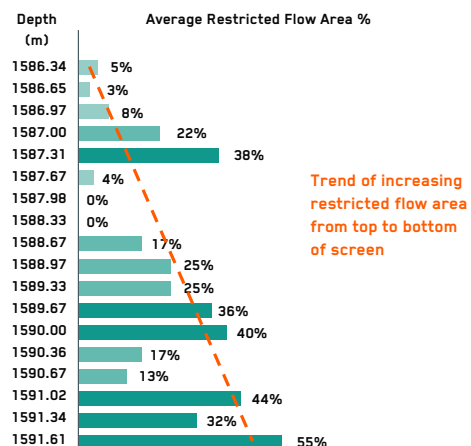
Figure 4: Average Restricted Flow Area Per Base Hole

Having demonstrated that the integrity of the screen was indeed intact, the operator satisfied the legislative requirements to continue operation of the well. The plugging of the base holes was noted, but the operator elected to take no further action at this time and would assess changes in the levels of plugging during subsequent inspections. From this time-lapse information a rate of change could be calculated to provide input for decision making on when to schedule wellbore and screen clean-up interventions.
