SandVA

INSPECTION & ANALYSIS OF SAND CONTROL IN GAS STORAGE WELLS

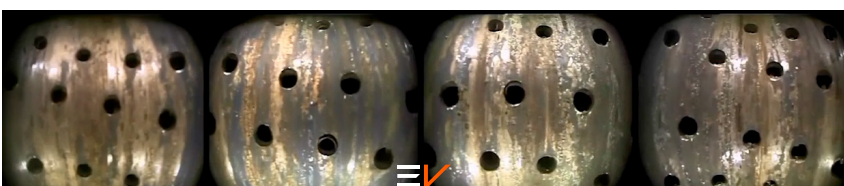
Figure 1: Optis Infinity Raw Images

As the operator wished to obtain a detailed, 360° assessment of screen condition the Optis Infinity M125 was selected to determine and understand well status. Previous technology relied on a single side view camera, rotated by an electric motor, requiring lengthy start and stop operations to capture all base holes within the sand screen. Optis Infinity, however, is equipped with 4 cameras in the same plane offset by 90 degrees, allowing for full 360° coverage of the well in a single continuous pass. The images in **fig.1** demonstrate the high-quality imaging acquired with the Optis Infinity M125, allowing for the analysis of screen integrity. The captured footage was transferred electronically to an EV data center where the condition of the screens were analyzed in detail.

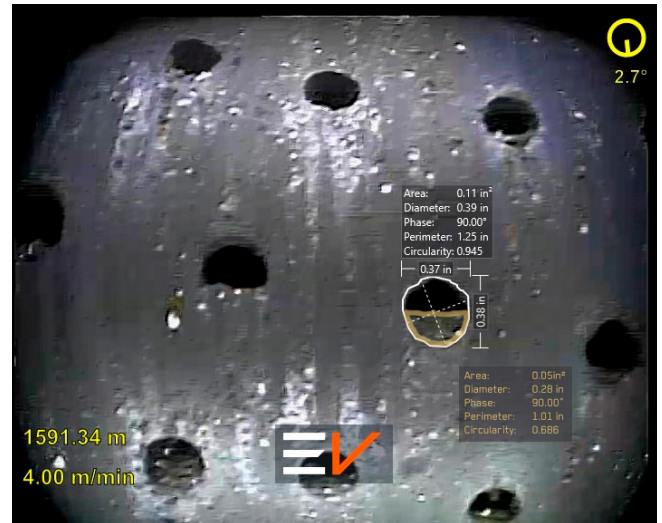
Figure 2: Dimensioned Base Holes Image

Following the visual assessment, individual base holes were then dimensioned at selected depths and azimuths (**fig.2**). As the well was near vertical over the sand screens the azimuth of measured holes were assigned to 90° sectors based on visual indications of the low side of the wellbore such as debris movement and tool string decentralization. 54% of the base holes were partially restricted (plugged) with debris having a sand-like appearance. **Fig.4** reveals a trend that emerged of increasing restricted flow area from the top to the bottom of the screen.

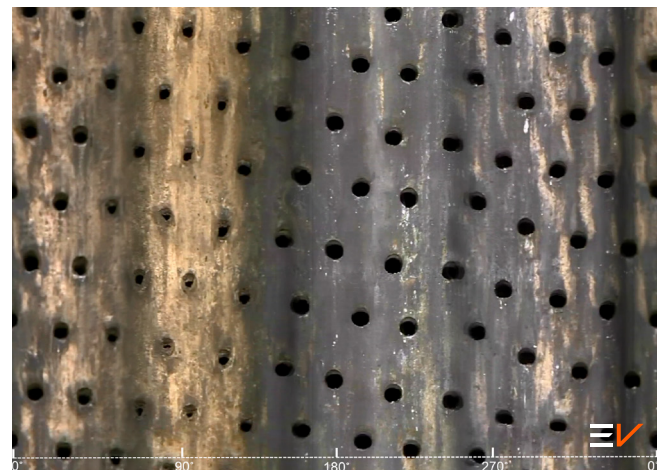
Figure 3: Processed 'Mosaic' Image

Mosaic images for each screen interval were created to provide an optimal medium for visual inspection of more than 2,500 base holes present in each assembly. Zones of specific interest can be quickly identified from such images as changes in pattern, hue and light intensity are easily identified. **Fig.2** provides an example of a 20cm interval near the top of the screen. This shows a deposit of sand like material on the tubular wall, along with partially plugged base holes particularly around the 90° azimuth. There was no visual evidence of erosion, however a trend of increasing restricted flow area emerged from the top to bottom of the screen (**Fig.4**).
