RestrictionVA

UNDERSTANDING WELLBORE HOLD-UP ISSUES

WELLBORE DEFORMATION

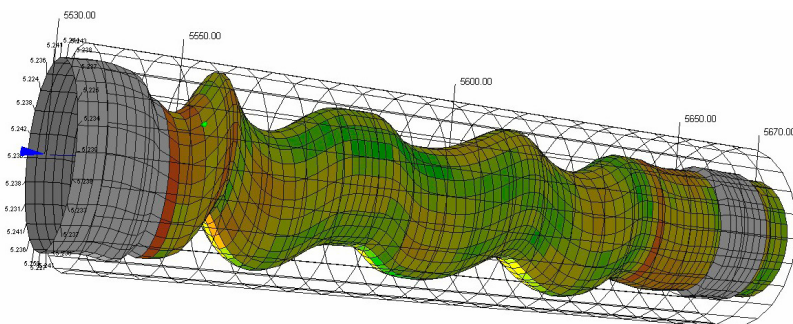
Figure 1: PDA 3D View of Helically Buckled Casing

The liner top was inspected and the geometry was confirmed to be normal. A Pipe Deformation Analysis (PDA) was undertaken based on data from the caliper (**Fig.1**), confirming the presence of helical buckling above the liner hanger. A drift analysis was provided to understand the limits for access and identify the optimal BHA to pass the restriction (**Fig.4**). This enabled the operator to modify the design of their plug and perf string to pass through the deformation, helping put the intervention back on track.

Further RestrictionVA analysis was carried out based on data obtained from the multi-finger caliper. Firstly, a Pipe Deformation Analysis (PDA) was undertaken to define and quantify the 3D geometry of the tubulars that may have been sheared, buckled or deformed by other mechanisms (**Fig.1**).

This process confirmed the presence of helical buckling in the casing and the reason why the original plug and perf string was unable to descend to the target depth. Then, by simulating the passage of multiple BHAs through this 3D geometry, a drift analysis was provided to understand the limits for access and identify the optimal BHA to pass the restriction (**Fig.4**).

The quantified information provided by RestrictionVA enabled the operator to design their plug and perf string to fit through the casing deformation, helping them put the operation back on track and deliver the well successfully with minimal disruption.

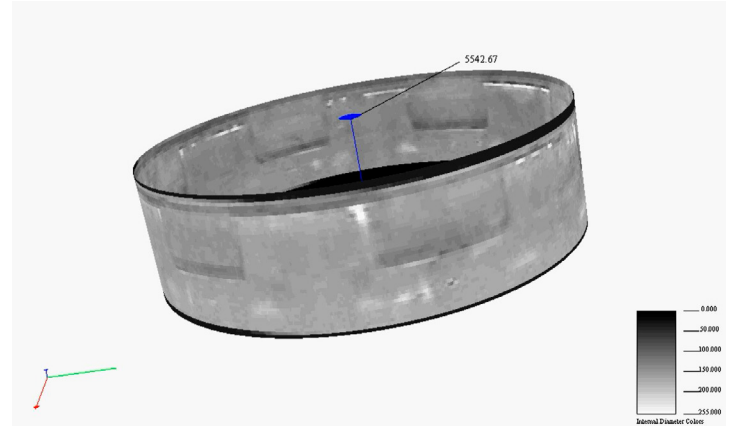
Figure 2: 3D Model of Liner Top

The liner top was inspected and a full 360-degree 3D model was provided (**Fig.2**). No visible signs of damage were identified and the geometry is confirmed to be normal. However further up the casing, the caliper data processed on MIPSPro indicated that the casing was helically buckled above the liner hanger (**Fig.3**).
