RestrictionVA

UNDERSTANDING WELLBORE HOLD-UP ISSUES

WELLBORE DEFORMATION

HOLD-UP DETECTED

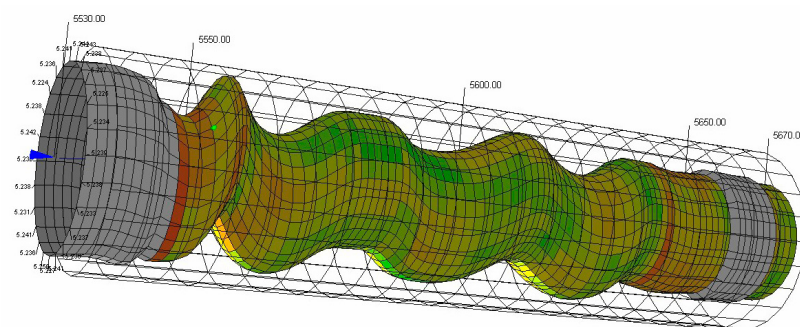
The liner top was inspected and the geometry was confirmed to be normal. A Pipe Deformation Analysis (PDA) was undertaken based on data from the caliper (**Fig.1**), confirming the presence of helical buckling above the liner hanger. A drift analysis was provided to understand the limits for access and identify the optimal BHA to pass the restriction (**Fig.4**). This enabled the operator to modify the design of their plug and perf string to pass through the deformation, helping put the intervention back on track.

Figure 1: PDA 3D View of Helically Buckled Casing

Further RestrictionVA analysis was carried out based on data obtained from the multi-finger caliper. Firstly, a Pipe Deformation Analysis (PDA) was undertaken to define and quantify the 3D geometry of the tubulars that may have been sheared, buckled or deformed by other mechanisms (**Fig.1**).

This process confirmed the presence of helical buckling in the casing and the reason why the original plug and perf string was unable to descend to the target depth. Then, by simulating the passage of multiple BHAs through this 3D geometry, a drift analysis was provided to understand the limits for access and identify the optimal BHA to pass the restriction (**Fig.4**).

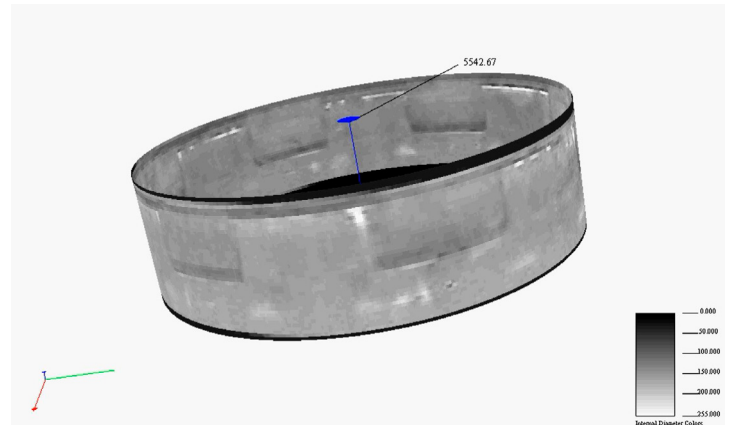
The liner top was inspected and a full 360-degree 3D model was provided (**Fig.2**). No visible signs of damage were identified and the geometry is confirmed to be normal. However further up the casing, the caliper data processed on MIPSPro indicated that the casing was helically buckled above the liner hanger (**Fig.3**).

Figure 2: 3D Model of Liner Top

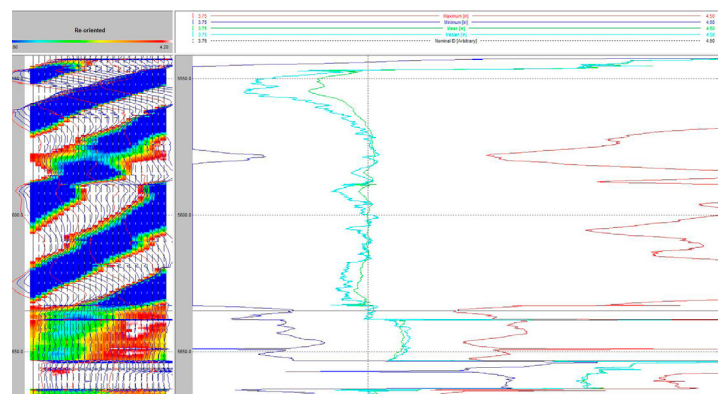
Figure 3: Caliper Data Processed on MIPSPro[®]
