## CORROSIONVA

# INSPECTION OF JET PUMP HOUSING

EV's Integrated Video Caliper (IVC) tool incorporates qualitative and quantitative measurements to assess wellbore corrosion.

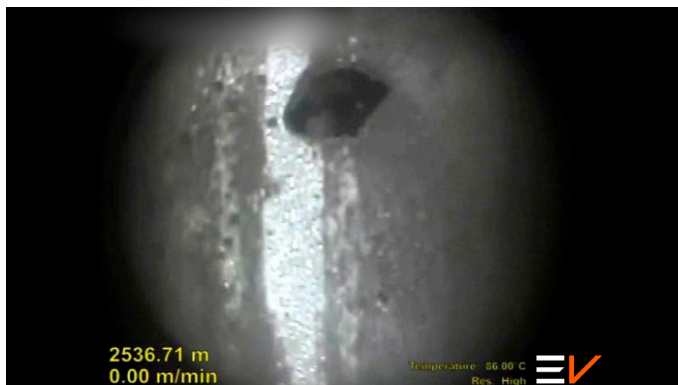
Figure 1: Sideview images of hole in Jet Pump Housing

Upon reaching the depth of interest, the side view camera identified a hole in the Jet Pump housing, which confirmed the early suspicions (**Fig.1**). The Optis visualization and dimensioning software platform was used to accurately measure and quantify the size of the hole - immediately at the well site (**Fig.2**).

The information provided by the IVC confirmed the integrity issue was isolated to the jet pump assembly. With this knowledge, the operator was able to manufacture a modified jet pump solution that isolated the hole. By changing the paths of power fluids and formation fluids, the operator managed to eliminate the differential pressure across the hole and recover the full functionality of the jet pump hydraulics, deferring a multi-million dollar workover.

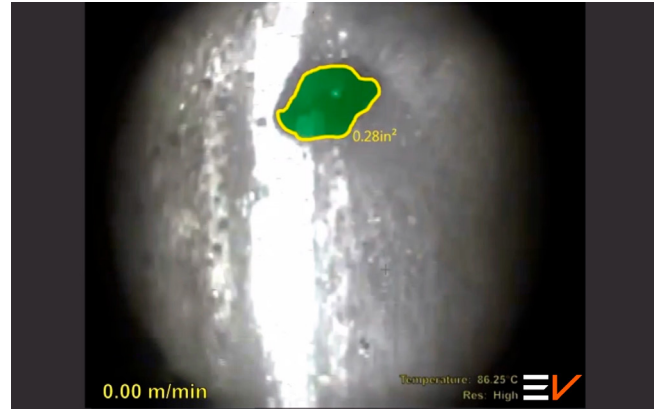
Figure 2: Dimensioned hole revealing the extent of damage

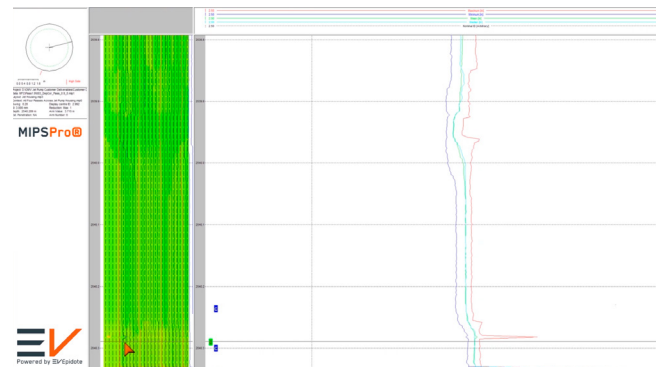
The visual assessment was confirmed by the multi-finger caliper data, with a single arm deflection (**Fig.3**).

Figure 3: Single arm deflection revealed in caliper data

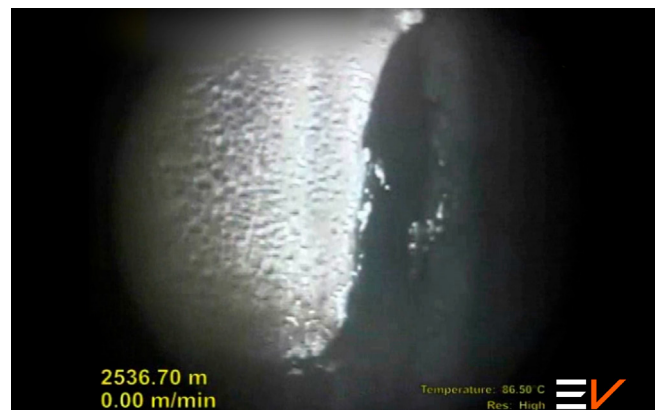
The 360 degree inspection of the jet pump assembly identified further anomalies with the jet pump housing, with both the downview and sideview cameras revealing a severe scaling issue, indicating a need for downhole chemical injection (**Fig.4**).

Figure 4: Sideview images revealing severe scaling issue
