FishVA

SUCCESSFUL FISH RECOVERY FOR FRAC HIT AFFECTED WELL

EV's memory camera provides valuable insight and quantifiable data to assist with complex fishing operations

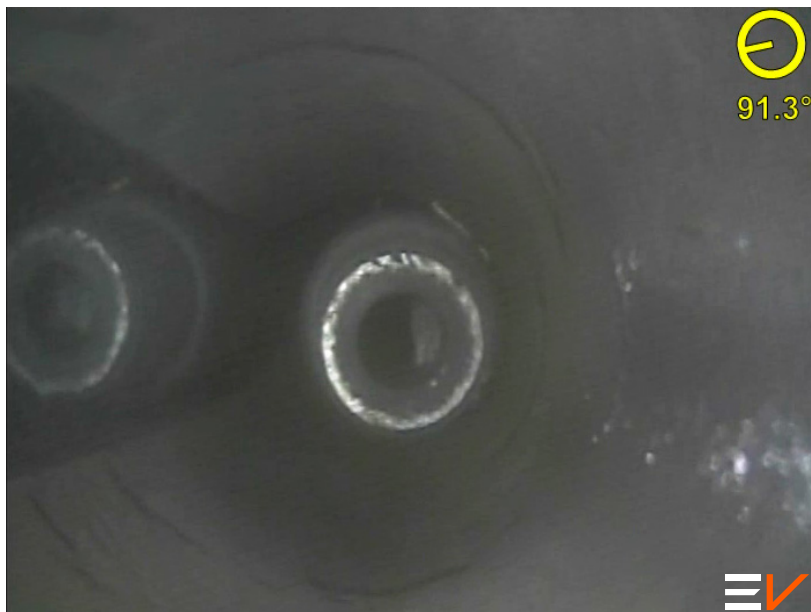
The high-definition video provided unique glimpse of the mill's position inside the collapsed casing (**Fig.1**). The real value, however, was delivered by measurements from FishVA, which provided detailed measurements of the gap between the mill and the casing (**Fig.2**), allowing the operator to customize their fishing job. With this information, the operator was able to successfully retrieve the mill on the next attempt, and complete the well for subsequent production.

Figure 1: Image of stuck mill. The assembly is positioned on the low side of the casing (centre), while its image is reflected on the gas/water interphase located on the high side of the well

The acquired video footage provided crystal-clear indication of the mills' position, with the mills' threaded end sitting far closer to the low side of the hole. A reflection of the mill can be seen on the liquid/gas interphase at the high side position (**Fig.1**). It was also evident from the images that the casing section was oval-shaped, with one axis clearly longer than the other. The client suspected a stimulation-induced pressure front (aka. frac hit) may have damaged the casing, which would explain the problems trying to pass through while running-in-hole. Substantial casing wear was also evident throughout, suggesting that pipe integrity might be compromised resulting from multiple coiled tubing runs.

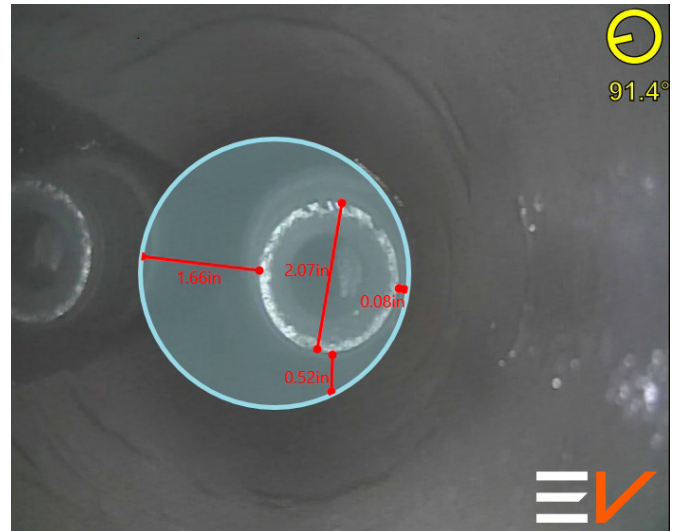
To get a complete understanding of the mill's status downhole, EV analyzed the video footage with its FishVA service in-situ, revealing that the stand-off on the mill's threaded end was almost 21 times larger on the high side (1.66 in.) than the low side (0.08 in.) of the casing (**Fig.2**). These detailed measurements provided the operator with the necessary information to modify an overshot and successfully recover the mill, substantially reducing operational time and cost when compared to similar operations.

Figure 2: Image of mill post dimensioning
