SUCCESSFUL FISH RECOVERY FOR FRAC HIT AFFECTED WELL

EV's memory camera provides valuable insight and quantifiable data to assist with complex fishing operations

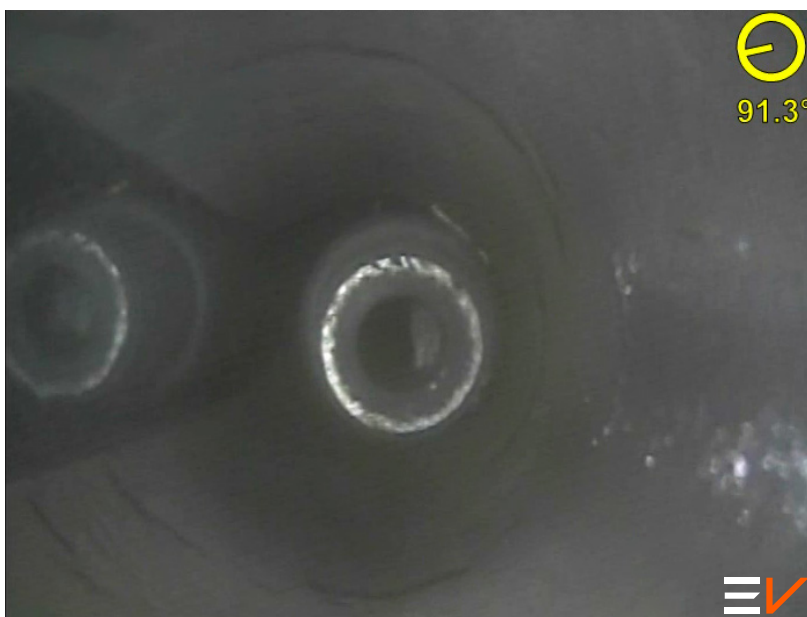
Figure 1: Image of stuck mill. The assembly is positioned on the low side of the casing (centre), while its image is reflected on the gas/water interphase located on the high side of the well

The high-definition video provided unique glimpse of the mill's position inside the collapsed casing (**Fig.1**). The real value, however, was delivered by measurements from FishVA, which provided detailed measurements of the gap between the mill and the casing (**Fig.2**), allowing the operator to customize their fishing job. With this information, the operator was able to successfully retrieve the mill on the next attempt, and complete the well for subsequent production.

The acquired video footage provided crystal-clear indication of the mills' position, with the mills' threaded end sitting far closer to the low side of the hole. A reflection of the mill can be seen on the liquid/gas interphase at the high side position (**Fig.1**). It was also evident from the images that the casing section was oval-shaped, with one axis clearly longer than the other. The client suspected a stimulation-induced pressure front (aka. frac hit) may have damaged the casing, which would explain the problems trying to pass through while running-in-hole. Substantial casing wear was also evident throughout, suggesting that pipe integrity might be compromised resulting from multiple coiled tubing runs.

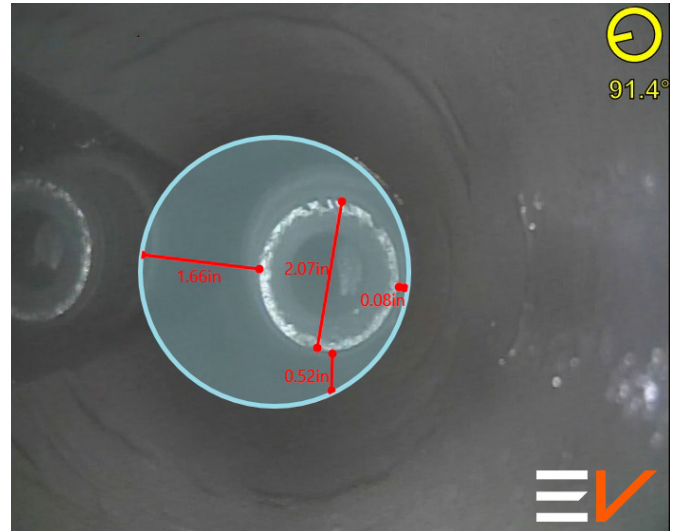
To get a complete understanding of the mill's status downhole, EV analyzed the video footage with its FishVA service in-situ, revealing that the stand-off on the mill's threaded end was almost 21 times larger on the high side (1.66 in.) than the low side (0.08 in.) of the casing (**Fig.2**). These detailed measurements provided the operator with the necessary information to modify an overshot and successfully recover the mill, substantially reducing operational time and cost when compared to similar operations.

Figure 2: Image of mill post dimensioning
