Optis Technology

COMPLEX FISHING OPERATION ENABLES SUCCESSFUL P&A

EV's real-time camera provides valuable insight and visual data to assist with complex fishing operations

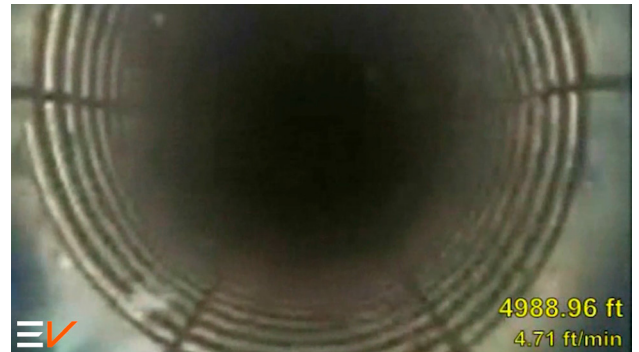
After adapting the drill-pipe string to include a wireline side entry sub, a shortened camera assembly could be run through an overshoot to inspect the top of fish, whilst circulating clear fluid into the area of interest.

Figure 2: Downview footage of shortened camera assembly running through an overshoot

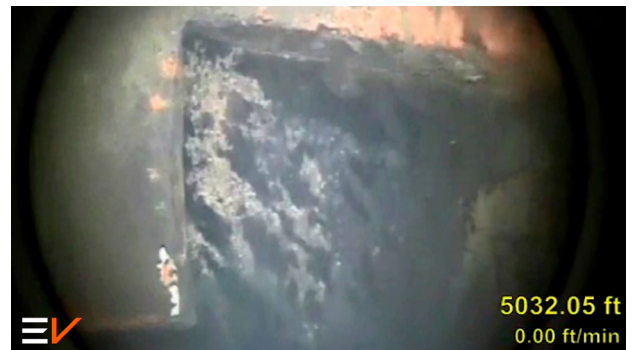
The side view camera video footage revealed the top of the tubing against the casing wall, with broken off cut lip guide deformed around it.

Figure 3: Sideview footage of deformed cut lip guide

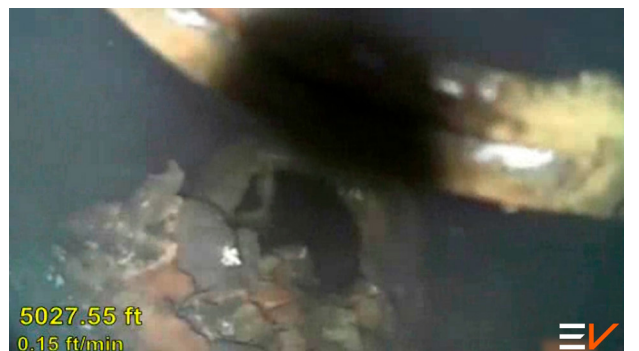
High quality downview footage revealed the top of the tubing, trapped against the casing wall by the deformed cut lip guide along with some debris.

Figure 4: Downview footage of top of tubing trapped against the casing wall by the deformed cut lip guide along with debris

With the visual confirmation of fish location and status, the operator was able to successfully retrieve the multiple fish on subsequent runs, and proceed with the plug & abandonment schedule.
