REVEALING COLLAPSED TUBING IN A GAS WELL

EV's memory camera provides valuable qualitative assessment of restricted wellbore access.

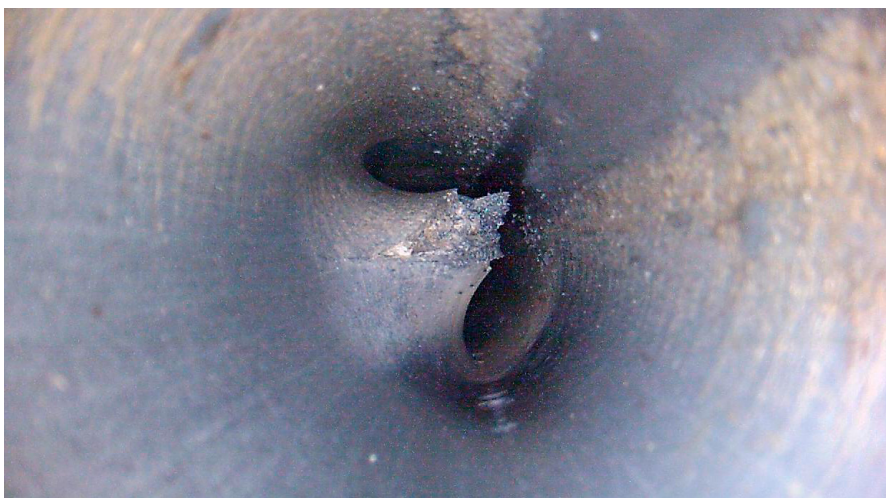
Figure 1: Tubing collapse

Upon reaching 9,100 feet depth, the high definition downview camera instantly revealed the cause and severity of the restriction. The crystal clear images revealed what appears to be a collapse in the tubing (**Fig.1**), which the operator believed to be potentially caused by moving salt rafts within the formation. Although not the best outcome for the operator, the information provided by the camera survey enabled an important decision to be made immediately, helping to avoid any unnecessary expenditure and non-productive time.

With the restriction now diagnosed, the operator had no choice but to shut-in the well, with a view to potentially revisit it in the future, when the economic viability of a workover is justified.

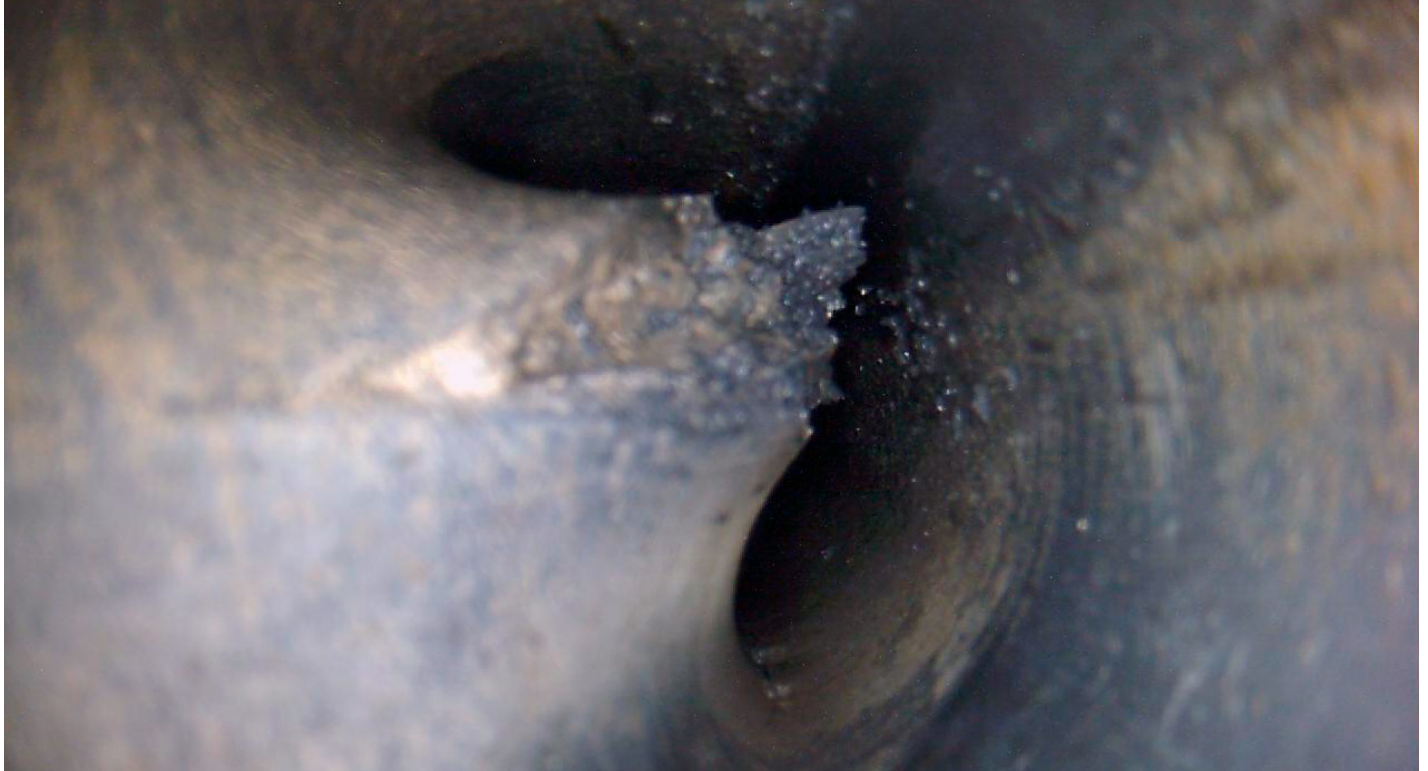
Figure 1: Extent of restriction preventing equipment access

Upon reaching 9,100 feet depth, the high definition downview camera instantly revealed the cause & severity of the restriction (**Fig.1**). The crystal clear footage reveals what appears to be a collapse in the tubing. The operator believes this was potentially caused by moving salt rafts within the formation.

Although not the best outcome for the operator, the information provided by the camera survey enabled an important decision to be made immediately, helping to avoid any unnecessary expenditure and non-productive time.
