Optis Technology

REVEALING COLLAPSED TUBING IN A GAS WELL

EV's memory camera provides valuable qualitative assessment of restricted wellbore access.

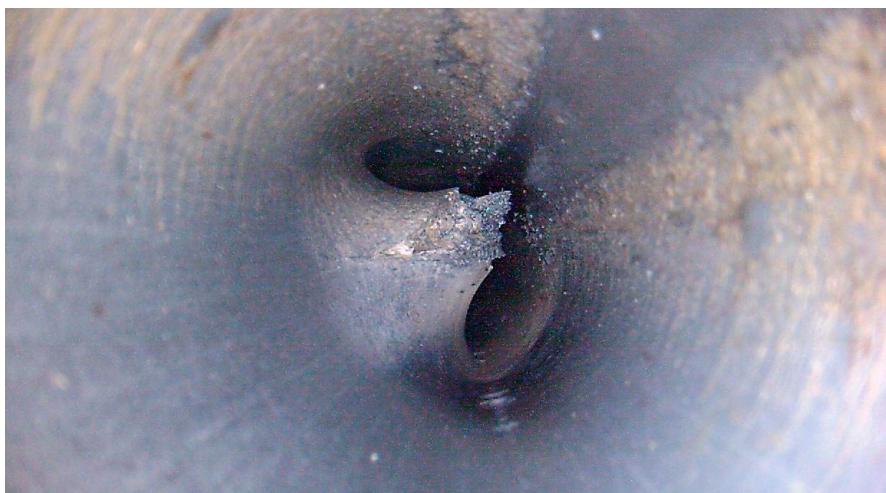
Figure 1: Tubing collapse

Upon reaching 9,100 feet depth, the high definition downview camera instantly revealed the cause and severity of the restriction. The crystal clear images revealed what appears to be a collapse in the tubing (**Fig.1**), which the operator believed to be potentially caused by moving salt rafts within the formation. Although not the best outcome for the operator, the information provided by the camera survey enabled an important decision to be made immediately, helping to avoid any unnecessary expenditure and non-productive time.

With the restriction now diagnosed, the operator had no choice but to shut-in the well, with a view to potentially revisit it in the future, when the economic viability of a workover is justified.

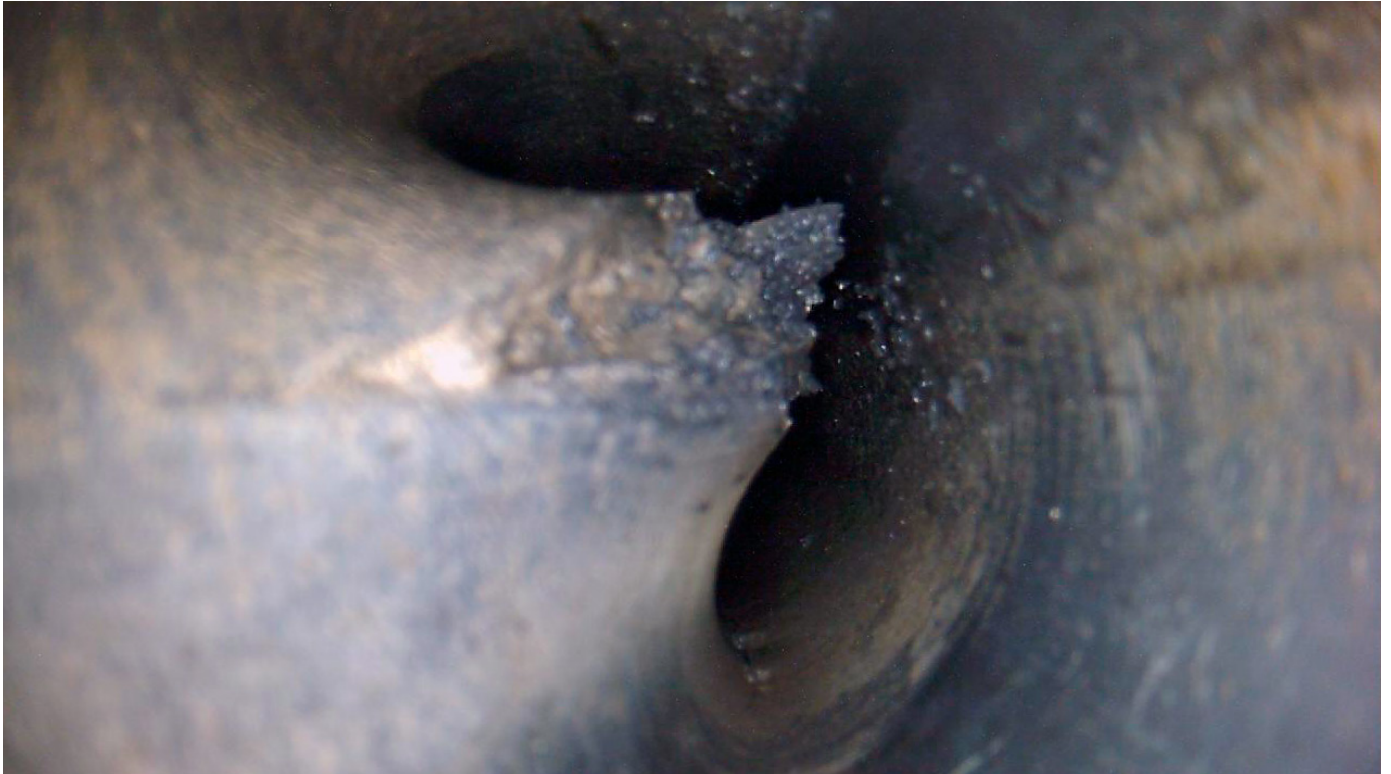
Figure 1: Extent of restriction preventing equipment access

Upon reaching 9,100 feet depth, the high definition downview camera instantly revealed the cause & severity of the restriction (**Fig. 1**). The crystal clear footage reveals what appears to be a collapse in the tubing. The operator believes this was potentially caused by moving salt rafts within the formation.
