RestrictionVA

QUANTIFYING RESTRICTIONS IN AN EXTREME REACH LATERAL

EV's Integrated Video Caliper (IVC) tool incorporates qualitative & quantitative measurements to identify the root cause of restricted wellbore access.

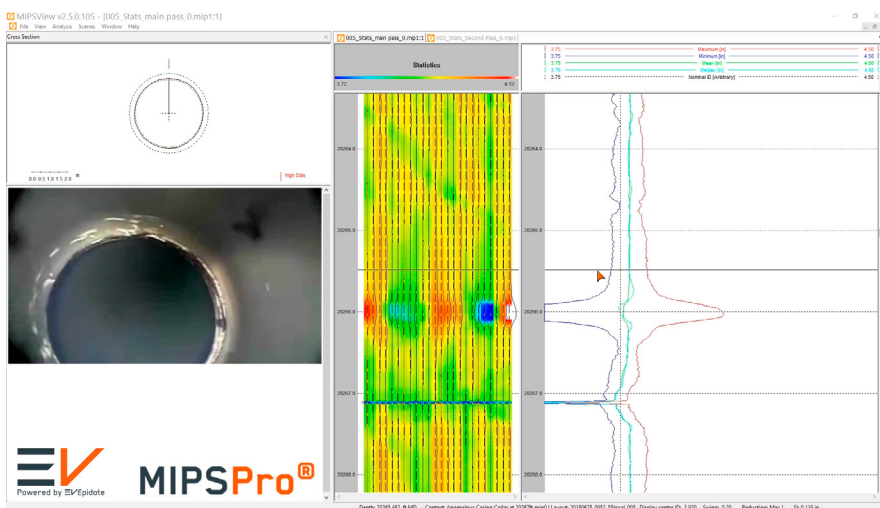
The caliper identified a number of anomalous casing collars that have smaller ID's than the expected drift ID of 3.795 inches.

Figure 1: Anomalous casing collar identified at 20,000 ft

The first anomalous casing collar, located at 20,000 ft, shows signs of ovalization as confirmed in the video footage (**Fig.1**). A further three casing collars were identified to have the same issue.

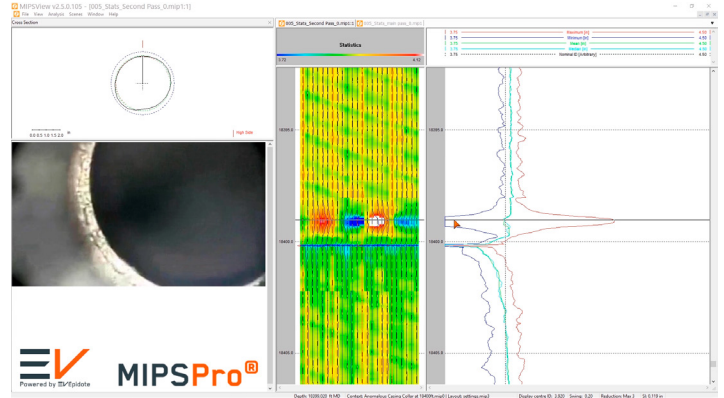
The anomalous collar at 18,400 feet, the closest anomaly to the suspected hold up depth, had a minimum ID of 3.460 inches (**Fig.2**), which is smaller than the dimensions of the original plug and perforating assembly. The 3D model helps illustrate the extent of the restriction (**Fig.3**).

The connection anomalies were diagnosed to be caused by 'over-torque' during make up, leading to changes in procedure for future wells to prevent reoccurrence.

Figure 2: Anomalous casing collar identified at 18,400 ft

With the quantitative information provided by RestrictionVA, the operator was able to run a modified plug and perf assembly to pass through the restriction and complete the well onto production.

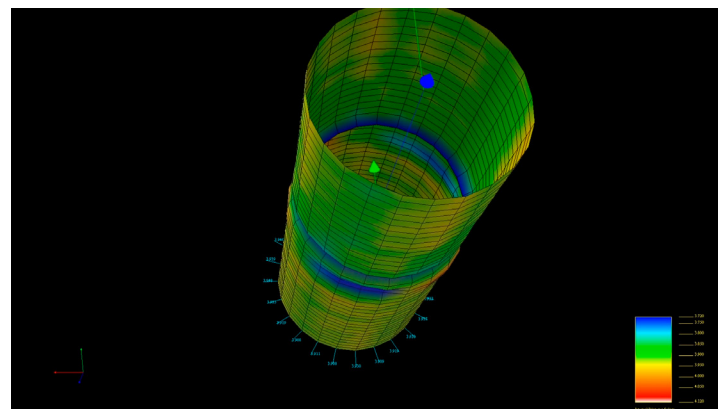
Figure 3: 3D Model of the casing collar

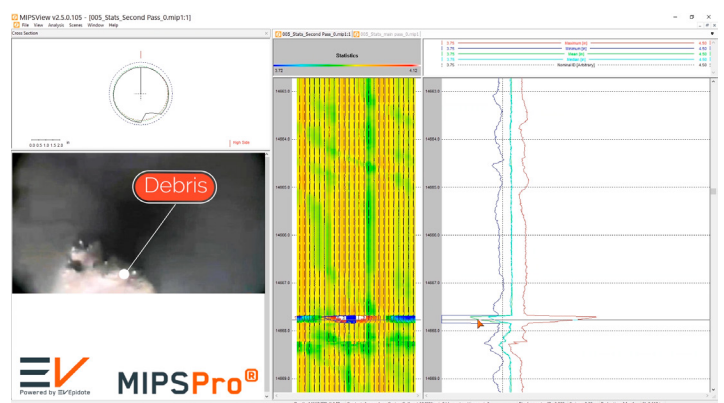
The most severe anomaly detected by the caliper was identified at 14,600 feet, with an ID of less than 2.6 inches. However, on closer inspection of the video footage this was found to be loose debris and not a deformed casing collar (**Fig.4**).

From this information, the operator was able to dismiss the anomaly, saving an unnecessary milling operation if misdiagnosed as another deformed casing collar, highlighting the value of the Integrated Video Caliper service.

Figure 4: Footage of debris and caliper response at 14,600 ft
