RestrictionVA

QUANTIFYING RESTRICTIONS IN AN EXTREME REACH LATERAL

EV's Integrated Video Caliper (IVC) tool incorporates qualitative & quantitative measurements to identify the root cause of restricted wellbore access.

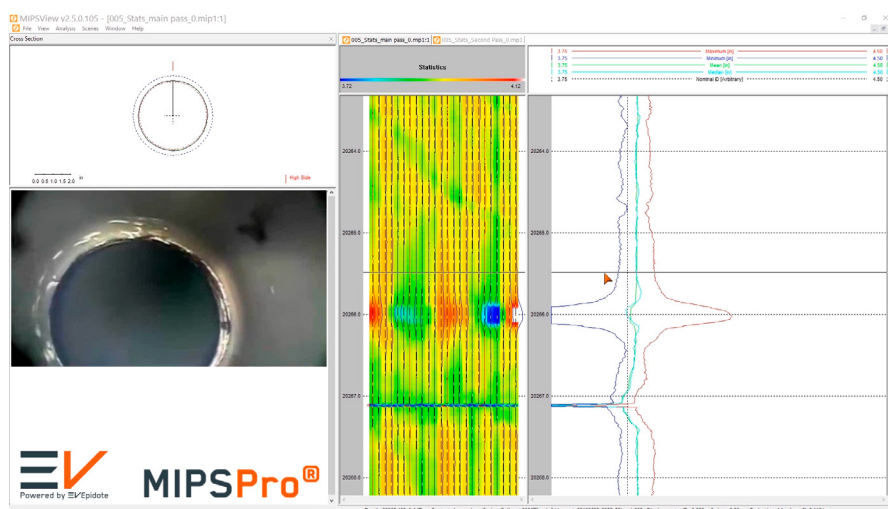
Figure 1: Anomalous casing collar identified at 20,000 ft

The first anomalous casing collar, located at 20,000 ft, shows signs of ovalization as confirmed in the video footage (**Fig. 1**). A further three casing collars were identified to have the same issue.

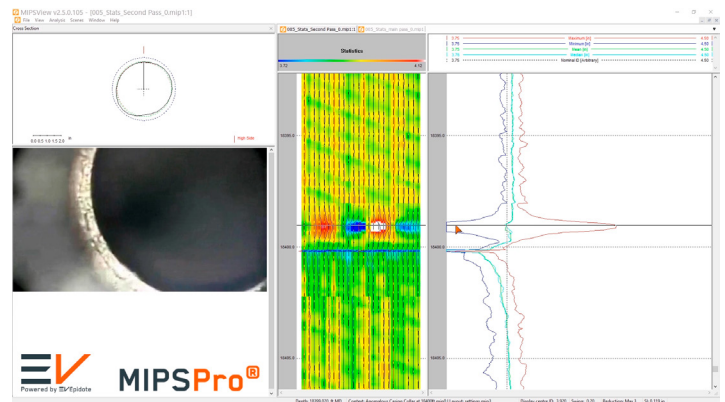
The anomalous collar at 18,400 feet, the closest anomaly to the suspected hold up depth, had a minimum ID of 3.460 inches (**Fig. 2**), which is smaller than the dimensions of the original plug and perforating assembly. The 3D model helps illustrate the extent of the restriction (**Fig. 3**).

The connection anomalies were diagnosed to be caused by 'over-torque' during make up, leading to changes in procedure for future wells to prevent reoccurrence.

Figure 2: Anomalous casing collar identified at 18,400 ft

With the quantitative information provided by RestrictionVA, the operator was able to run a modified plug and perf assembly to pass through the restriction and complete the well onto production.

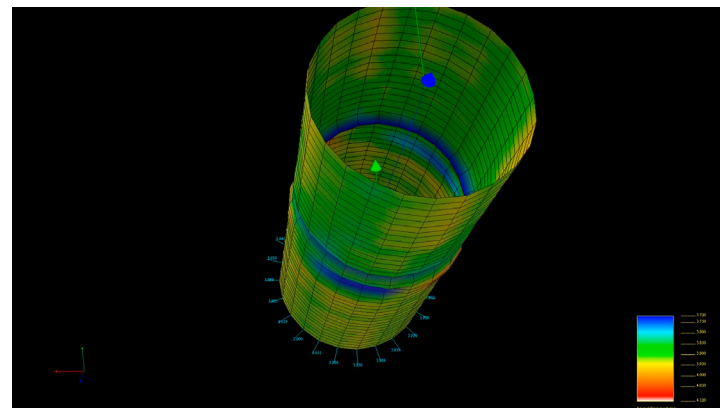
Figure 3: 3D Model of the casing collar

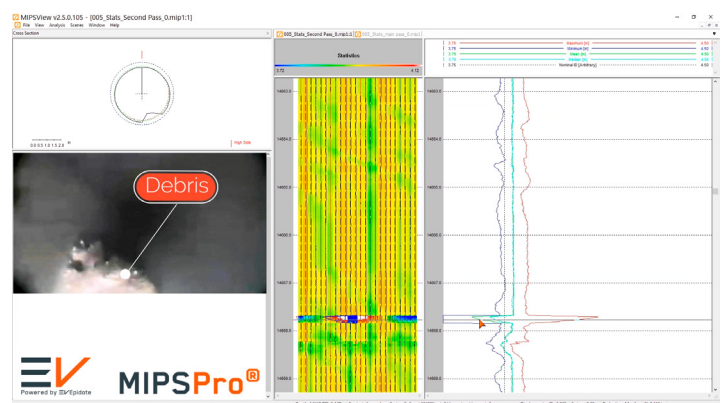
The most severe anomaly detected by the caliper was identified at 14,600 feet, with an ID of less than 2.6 inches. However, on closer inspection of the video footage this was found to be loose debris and not a deformed casing collar (**Fig. 4**).

From this information, the operator was able to dismiss the anomaly, saving an unnecessary milling operation if mis-diagnosed as another deformed casing collar, highlighting the value of the Integrated Video Caliper service.

Figure 4: Footage of debris and caliper response at 14,600 ft
