REVEALING EXPOSED FORMATION

WELL ABANDONMENT

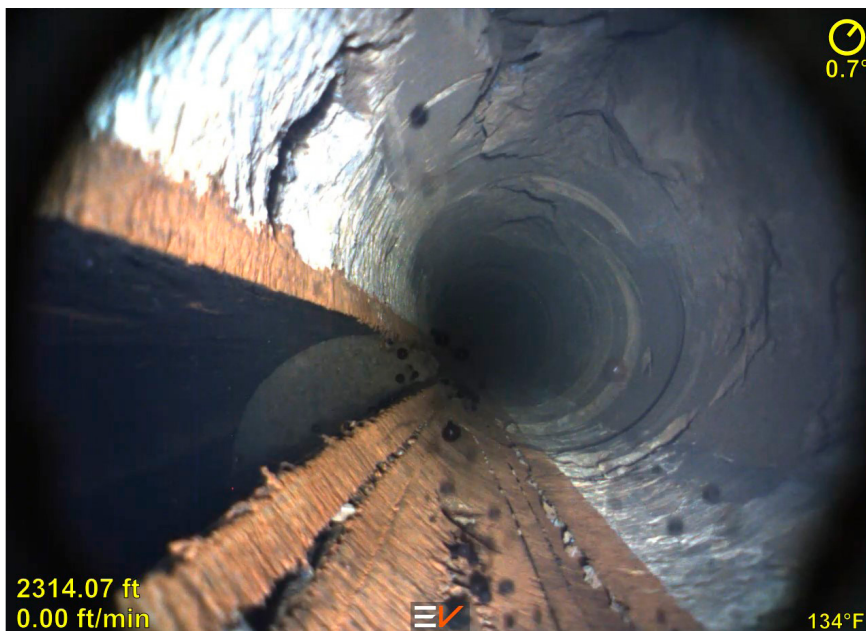
Figure 1: Downview camera revealing milling damage

The Optis Infinity camera was run in hole to a depth of 2300 feet, where the detailed real-time video footage confirmed that the mill had cut through the casing into the formation (**Fig.1**). The 360 degree perspective provided by the four sideview cameras reveal the extent of the damage where the casing was milled through entirely (**Fig.2**). Detailed and accurate measurements were provided of the gap in the casing, to provide quantitative evaluation of the damage and assessment of the severity (**Fig.3**).

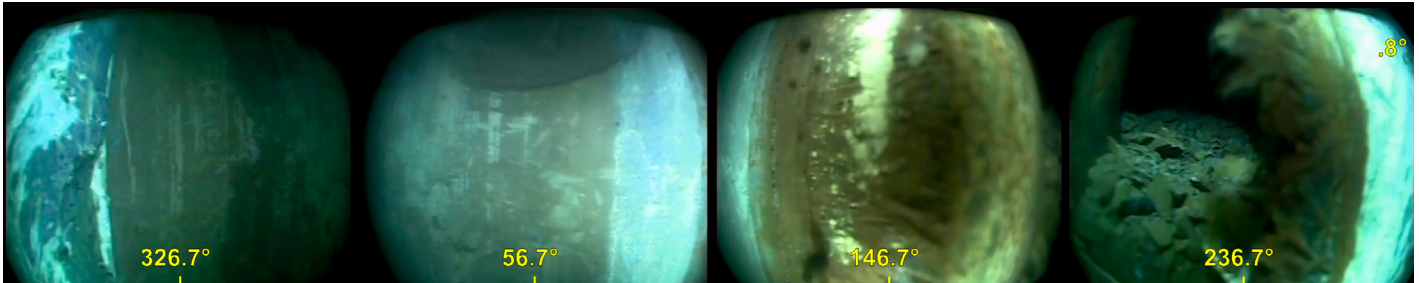
Figure 2: Sideview cameras revealing extent of damage

The Optis Infinity camera was run in hole to a depth of 2300 feet, where the detailed real-time video footage confirmed that the mill had cut through the casing into the formation (**Fig.1**). The 360 degree perspective provided by the four sideview cameras reveal the extent of the damage where the casing was milled through entirely (**Fig.2**).

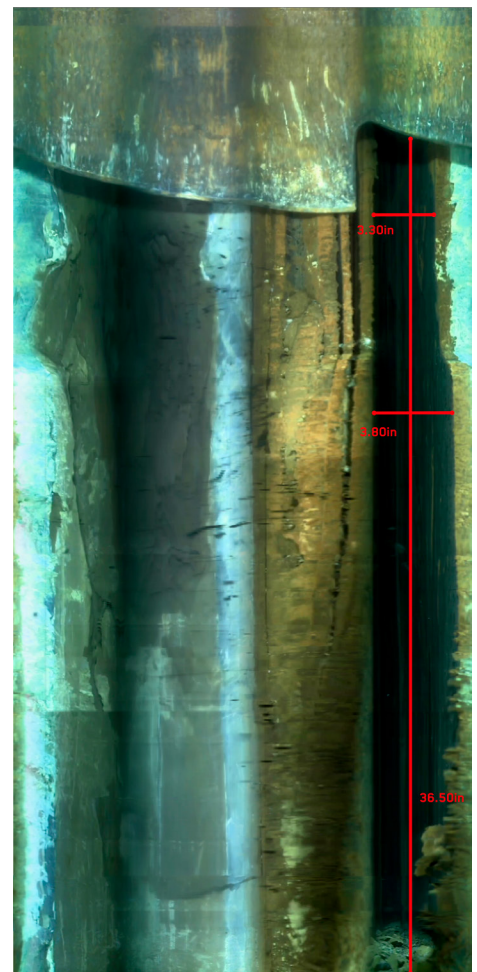
From the multiple concurrent views of the wellbore, a continuous image of the well environment was generated through an innovative process called 'mosaicing'. Figure 3 shows a 360 degree image of the damaged interval, helping to visualise the area of interest. EV's integrated dimensioning software platform enabled detailed and accurate measurements to be taken of the gap in the casing, providing quantitative evaluation of the damage and assessment of the severity (**Fig.3**).

Figure 3: Dimensioned 360° Mosaic image
