Visual Analytics

REVEALING EXPOSED FORMATION

WELL ABANDONMENT

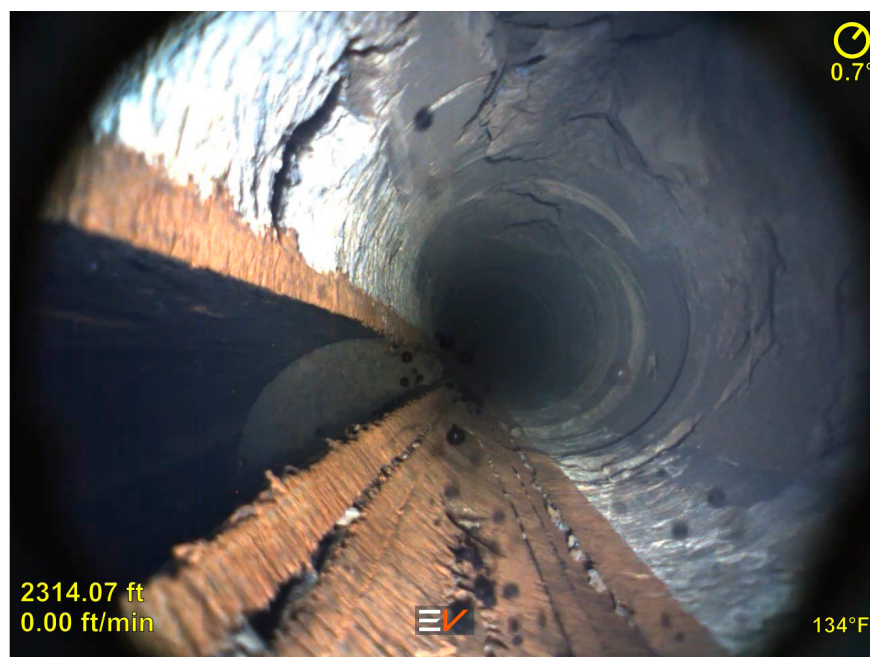
Figure 1: Downview camera revealing milling damage

The Optis Infinity camera was run in hole to a depth of 2300 feet, where the detailed real-time video footage confirmed that the mill had cut through the casing into the formation (**Fig.1**). The 360 degree perspective provided by the four sideview cameras reveal the extent of the damage where the casing was milled through entirely (**Fig.2**).

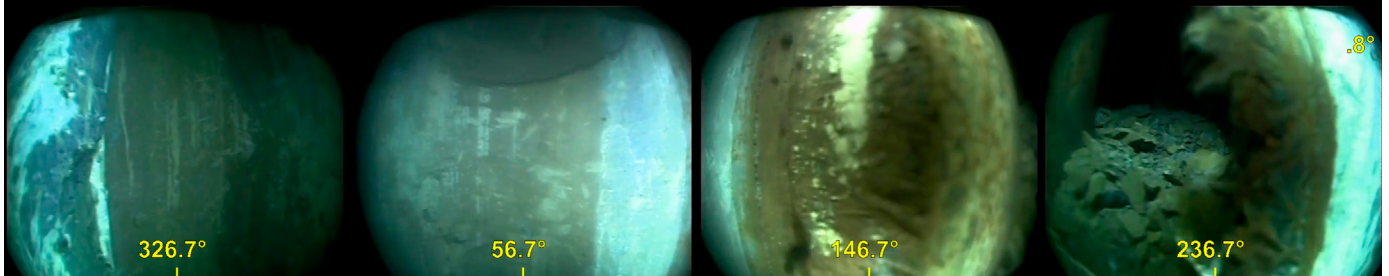
Figure 2: Sideview cameras revealing extent of damage

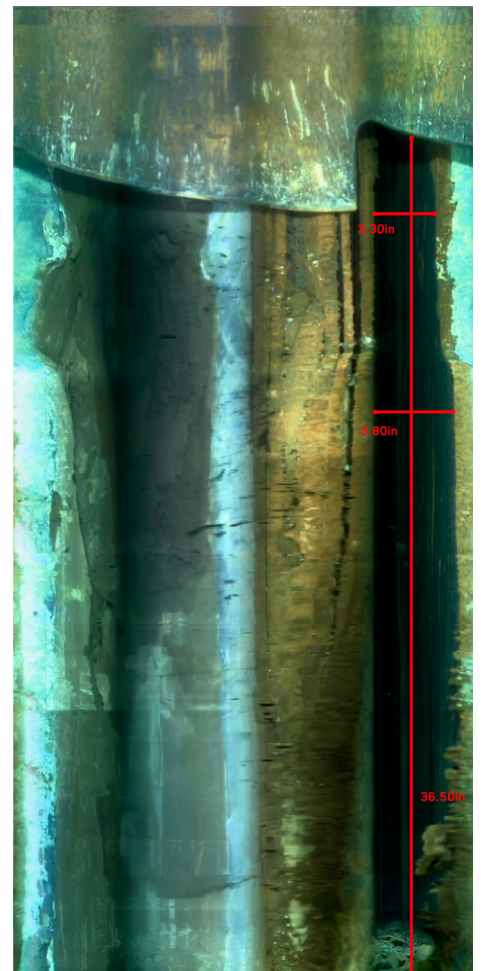
From the multiple concurrent views of the wellbore, a continuous image of the well environment was generated through an innovative process called 'mosaicing'. Figure 3 shows a 360 degree image of the damaged interval, helping to visualise the area of interest. EV's integrated dimensioning software platform enabled detailed and accurate measurements to be taken of the gap in the casing, providing quantitative evaluation of the damage and assessment of the severity (**Fig.3**).

Figure 3: Dimensioned 360° Mosaic image
