LeakVA

TUBING LEAK REPAIR ENABLED WITH VISUAL ANALYTICS

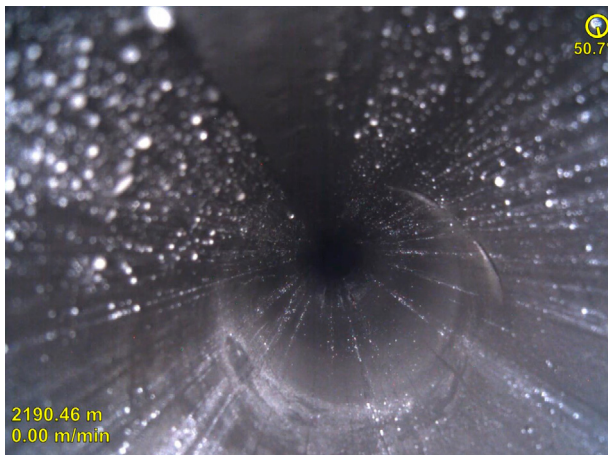
Figure 1: Downview image of leak points in pup joint

The camera was run in hole to a depth of 2100 metres. No visible corrosion, debris or sand accumulation was identified in the footage. However further down, the downview footage immediately revealed two small holes in the pup joint (*Fig.1*).

With the quantified information provided by LeakVA, and with no visible corrosion, debris or sand accumulation identified at the leak points, the operator has scheduled to set a pack-off straddle over the zone, to isolate the leak points and re-gain the integrity of the well.

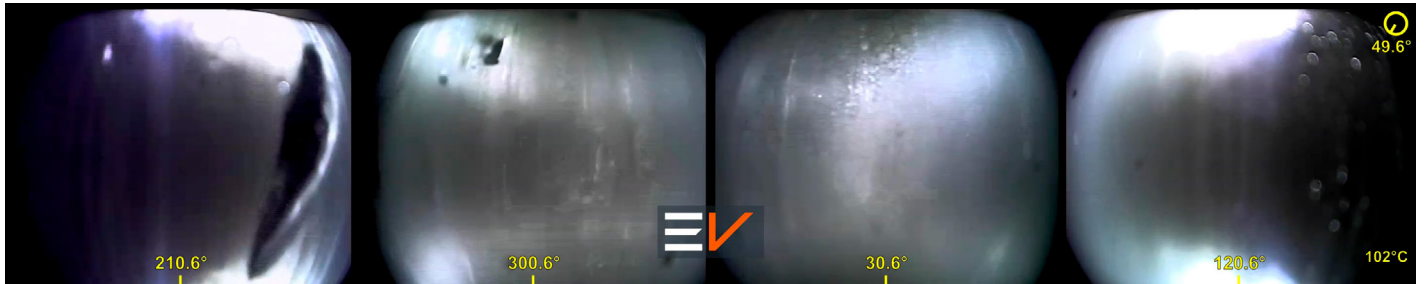
Figure 2: Sideview images revealing extent of damage

The four sideview cameras visualised the two leak points in more detail, revealing the full extent of the damage (*Fig.2*). EV's integrated visualisation and dimensioning software enabled detailed and accurate measurements of the two leak points, providing meaningful assessment of the severity of the damage (*Fig.3*).

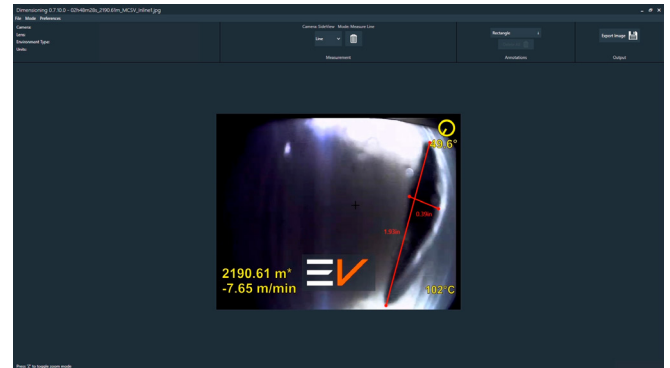
Figure 3: Detailed measurements of the severity of damage

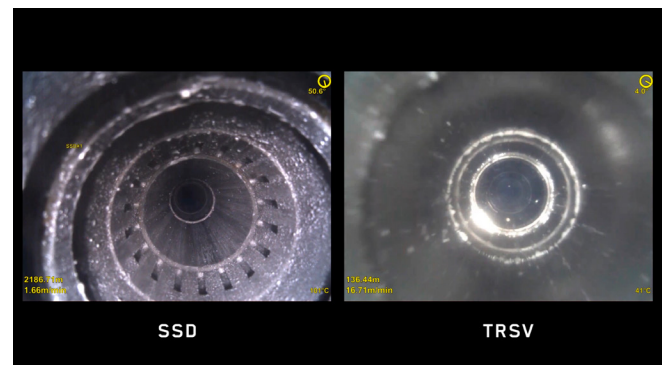
The Sliding Sleeve Devices and Safety Valve were also inspected and appeared to be in good condition with no scale build up or debris visible (*Fig.4*).

Figure 4: SSD & TRSV Inspection
