LeakVA

TUBING LEAK REPAIR ENABLED WITH VISUAL ANALYTICS

THE IMPACT OF DOWNHOLE LEAKS

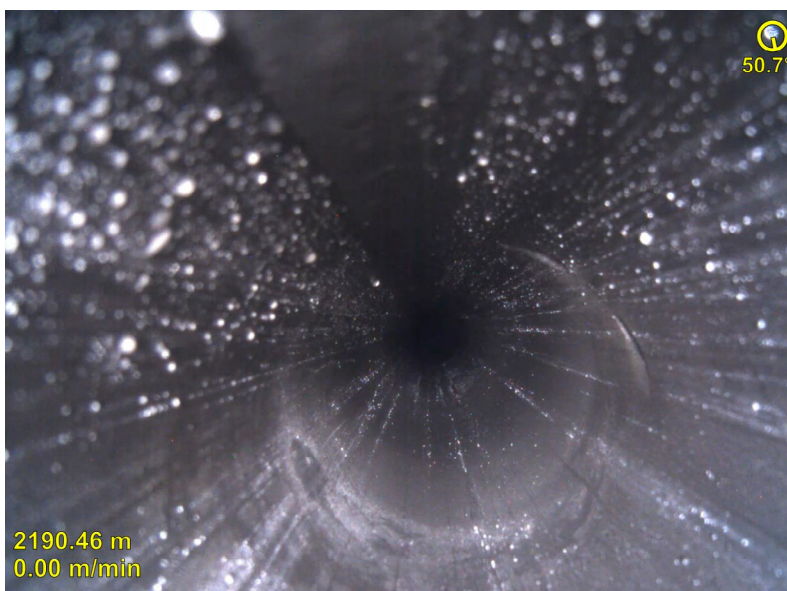
Figure 1: Downview image of leak points in pup joint

The camera was run in hole to a depth of 2100 metres. No visible corrosion, debris or sand accumulation was identified in the footage. However further down, the downview footage immediately revealed two small holes in the pup joint (*Fig.1*).

With the quantified information provided by LeakVA, and with no visible corrosion, debris or sand accumulation identified at the leak points, the operator has scheduled to set a pack-off straddle over the zone, to isolate the leak points and re-gain the integrity of the well.

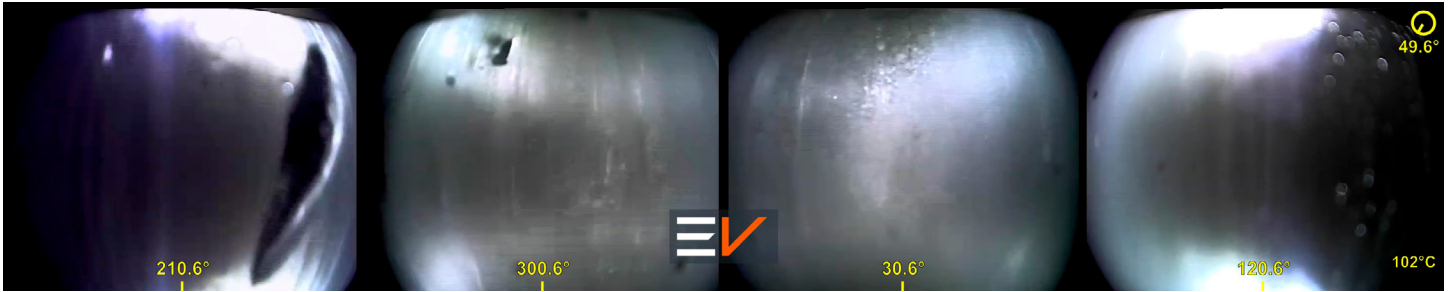
Figure 2: Sideview images revealing the extent of damage

The four sideview cameras visualised the two leak points in more detail, revealing the full extent of the damage (*Fig.2*). EV's integrated visualisation and dimensioning software enabled detailed and accurate measurements of the two leak points, providing meaningful assessment of the severity of the damage (*Fig.3*).

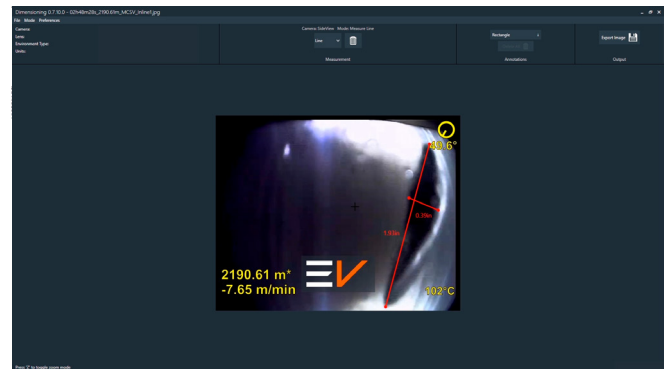
Figure 3: Detailed measurements of the severity of damage

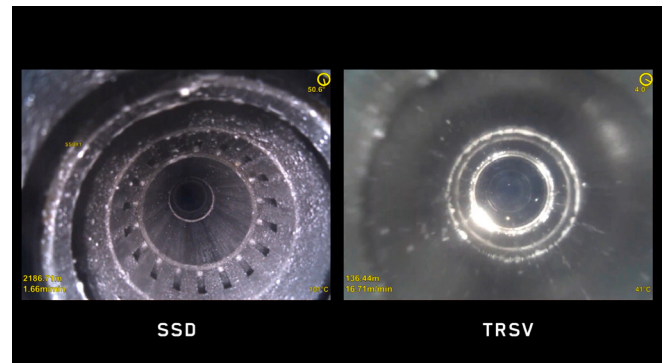
The Sliding Sleeve Devices and Safety Valve were also inspected and appeared to be in good condition with no scale build up or debris visible (*Fig.4*).

Figure 4: SSD & TRSV Inspection
