INTEGRITY RESTORED IN GAS WELL

EV's memory camera provides valuable qualitative assessment of well integrity.

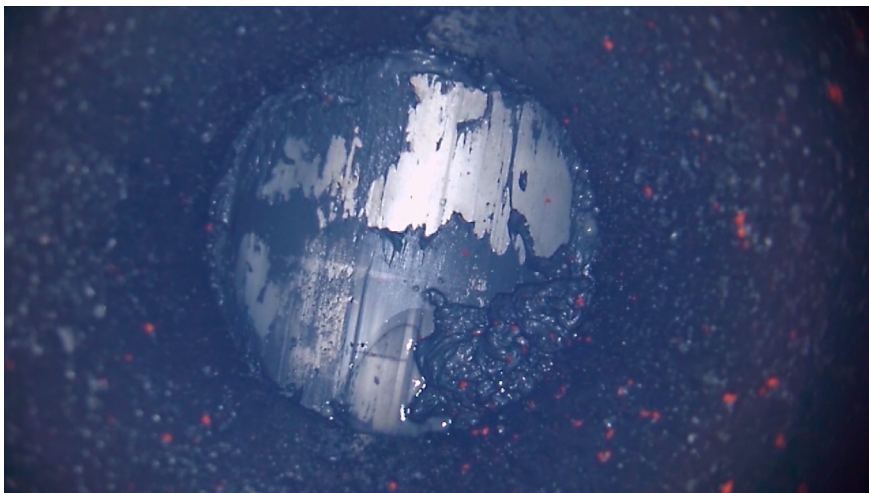
Figure 1: Downview image of SCSSSV

The camera was run to a depth of 460 metres where initial testing appeared to show the valve functioning well. The flow tube and flapper were seen to be moving freely, however the valve was still leaking (**Fig.1**).

With no obvious signs of damage, or issues that could be remediated in-situ, the decision was made to abort restorative efforts and proceed with the installation of a new insert safety valve.

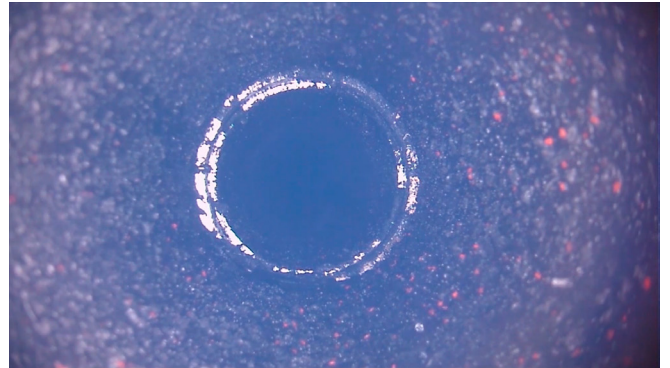
The footage also revealed a substantial build-up of grease deposits around the inner body of safety valve, but this was not believed to be affecting the operation of sealing performance of the device (**Fig.2**).

Figure 2: Grease deposits around inner body of SCSSSV

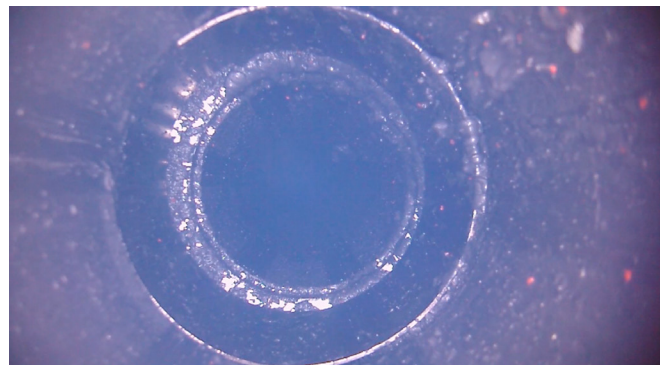
The camera was run for a second time to verify that the safety valve was successfully locked open and confirm the assembly was clean and ready to accept the insert device. The video footage revealed the flow tube and flapper were in the fully open position and that the landing nipple and seal-bore surfaces were clean and in good condition (**Fig.3**).

Figure 3: Locked open SCSSSV confirmation post clean-up

With the visual information provided by the camera that the preparation runs were successful, the operator was able to proceed with installing the wireline insertable safety valve.
