Optis Technology

INTEGRITY RESTORED IN GAS WELL

EV's memory camera provides valuable qualitative assessment of well integrity.

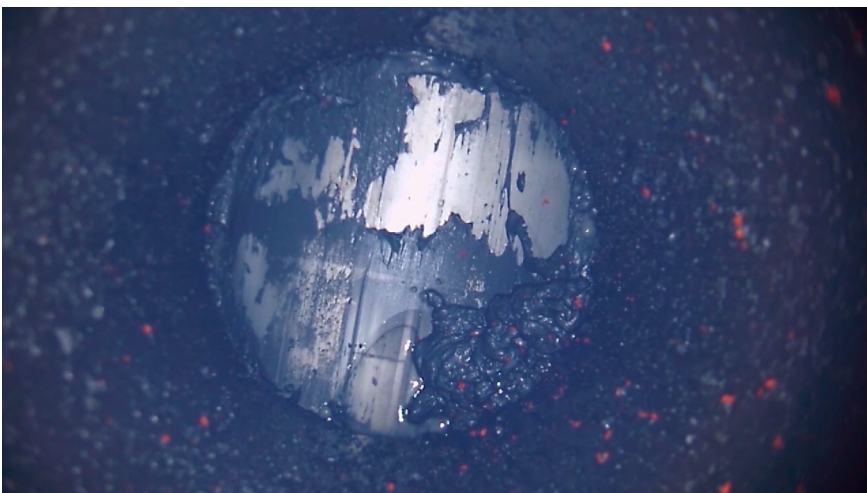
Figure 1: Downview image of SCSSSV

The camera was run to a depth of 460 metres where initial testing appeared to show the valve functioning well. The flow tube and flapper were seen to be moving freely, however the valve was still leaking (**Fig.1**).

With no obvious signs of damage, or issues that could be remediated in-situ, the decision was made to abort restorative efforts and proceed with the installation of a new insert safety valve.

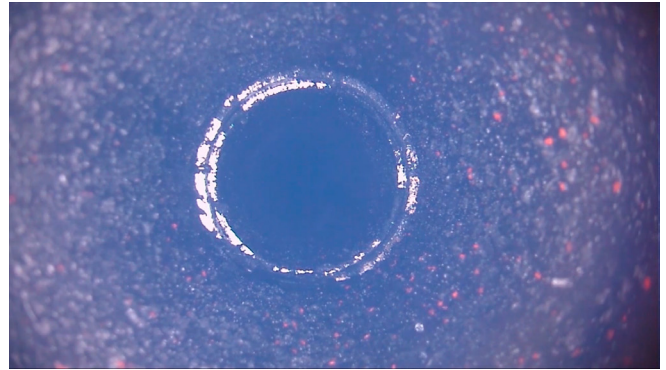
The footage also revealed a substantial build-up of grease deposits around the inner body of safety valve, but this was not believed to be affecting the operation of sealing performance of the device (**Fig.2**).

Figure 2: Grease deposits around inner body of SCSSSV

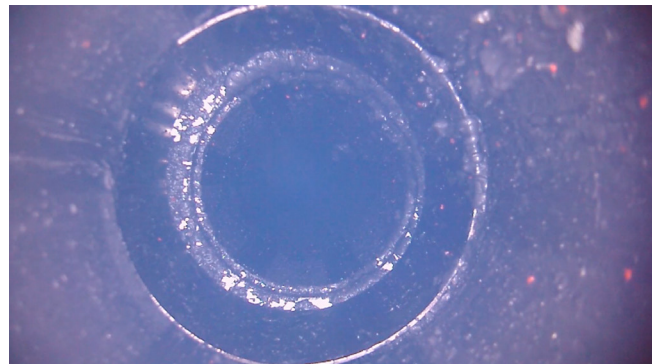
The camera was run for a second time to verify that the safety valve was successfully locked open and confirm the assembly was clean and ready to accept the insert device. The video footage revealed the flow tube and flapper were in the fully open position and that the landing nipple and seal-bore surfaces were clean and in good condition (**Fig.3**).

Figure 3: Locked open SCSSSV confirmation post clean-up

With the visual information provided by the camera that the preparation runs were successful, the operator was able to proceed with installing the wireline insertable safety valve.
