FishVA

EFFICIENT SALT PRODUCTION RESTORED

SALT CAVERN ISOLATED

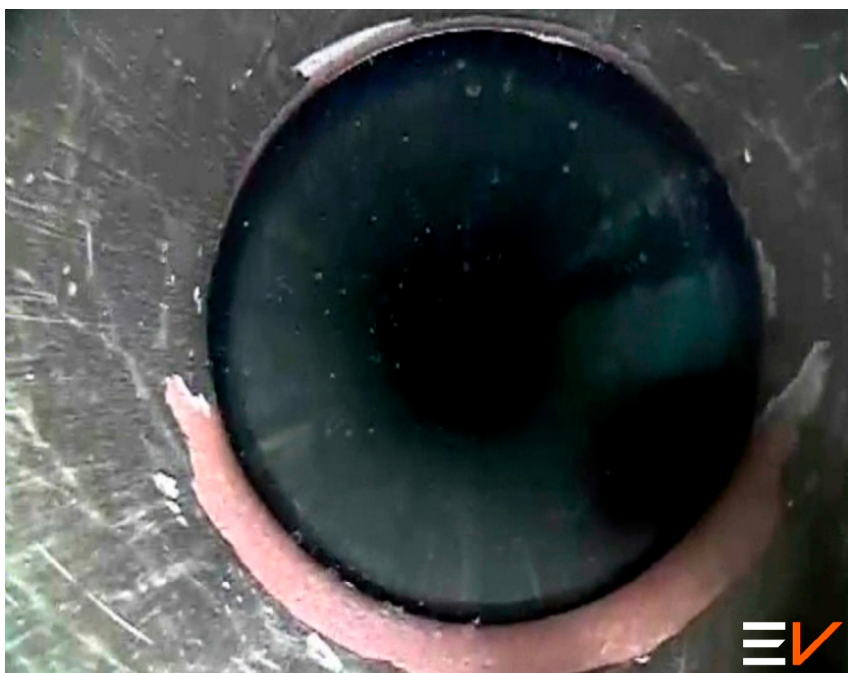
With multiple cuts required, EV's Optis® R125 camera was deployed on Electric-line to provide real-time visual confirmation of success at each stage of the operation. The camera was run downhole to the target depth, where the detailed real-time footage confirmed the 7 inch casing was successfully cut (**Fig.1**).

Figure 1: Downview image confirming successful 7 inch casing cut

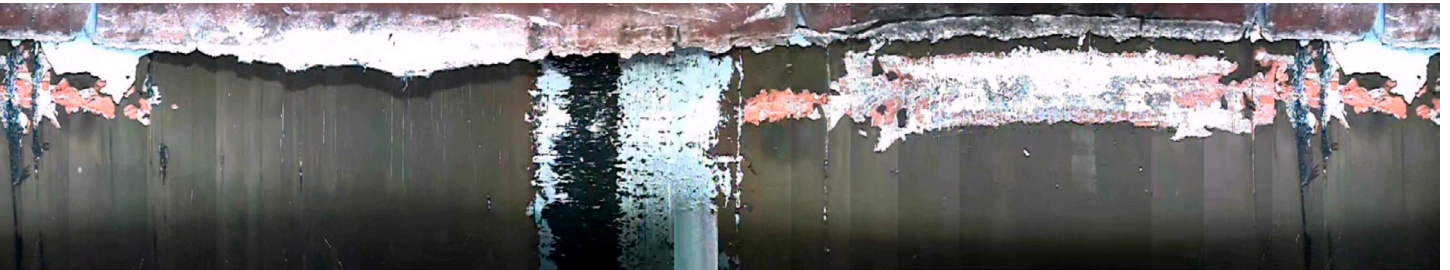
Figure 2: 360 degree stitched image providing a complete profile of the successful cut for clear and concise confirmation

The sideview footage revealed the cut in more detail (**Fig.3**), showing no anomalies. By applying proprietary Visual Analytics processes, a 360 degree continuous image was generated, providing a complete profile of the successful cut for clear and concise confirmation (**Fig.2**). Less than 10 metres below, the tail pipe was located standing upright within the 11 ¾ inch casing. With this visual confirmation, the operator was able to proceed with an operation to cut the 11 ¾ inch casing.

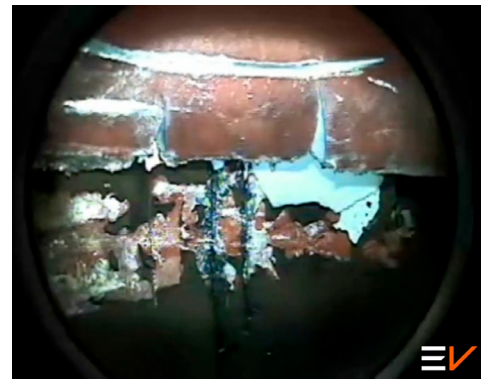
Figure 3: Sideview image confirming clean 7 inch casing cut

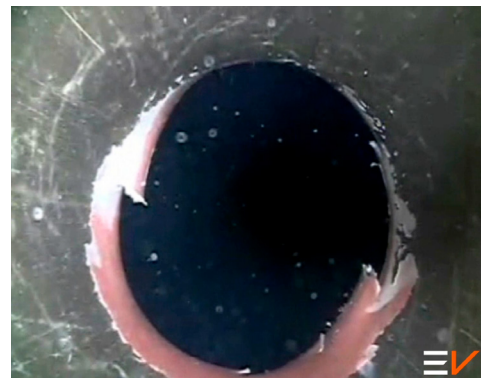
After cutting the 11 ¾ inch casing, the camera was run again to inspect the area. The real-time downview footage immediately revealed the successful casing cut (**Fig.4**), with the detailed sideview footage confirming a clean cut.

Figure 4: Downview image confirming 11 3/4 inch casing cut

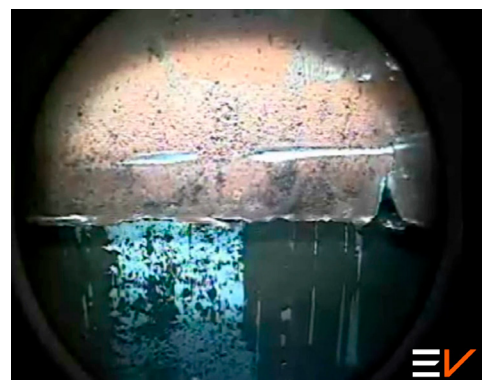
The final camera run confirmed the 7 inch casing cut, with the sideview footage confirming another successful cut (**Fig.5**). Upon running the camera deeper into the cavern, a clear passage to the bottom of the cavern was confirmed for the installation of a liner assembly.

Figure 5: Sideview image confirming final 7 inch casing cut

Finally, the operator installed a liner assembly at the bottom of the 7 inch casing, enabling successful restoration of efficient salt production.
