EFFICIENT SALT PRODUCTION RESTORED

SALT CAVERN ISOLATED

Frisia Zout, a leading salt producer in the Netherlands, were hit with an unexpected setback in their salt cavern well. The well produces high-quality vacuum salt, using a borehole brine process. Following a collapse of the cavern formations, the outer 11 ¾ inch casing was sheared, creating a fish that completely isolated the cavern, thereby preventing salt production.

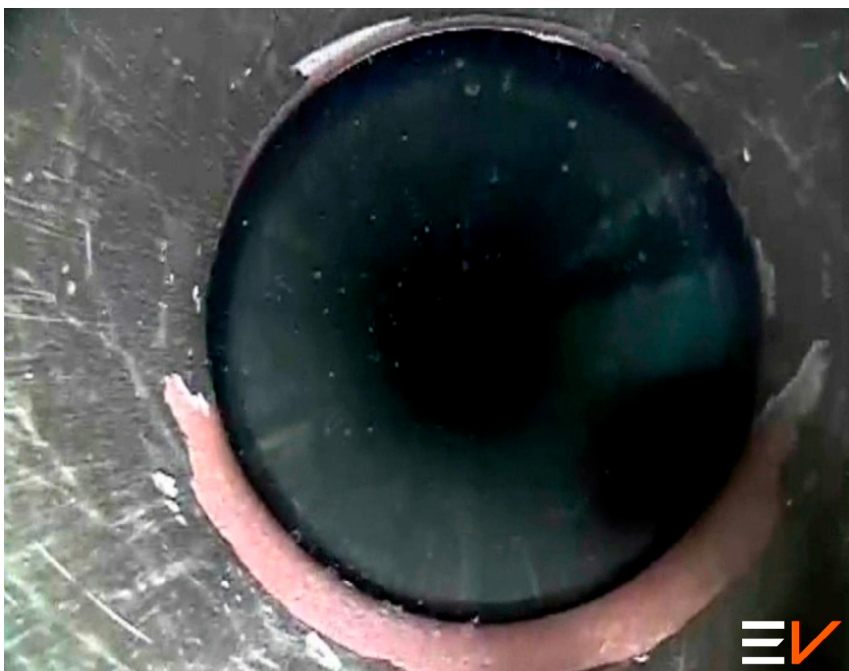
With multiple cuts required, EV's Optis® R125 camera was deployed on Electric-line to provide real-time visual confirmation of success at each stage of the operation. The camera was run downhole to the target depth, where the detailed real-time footage confirmed the 7 inch casing was successfully cut (**Fig.1**).

Figure 1: Downview image confirming successful 7 inch casing cut

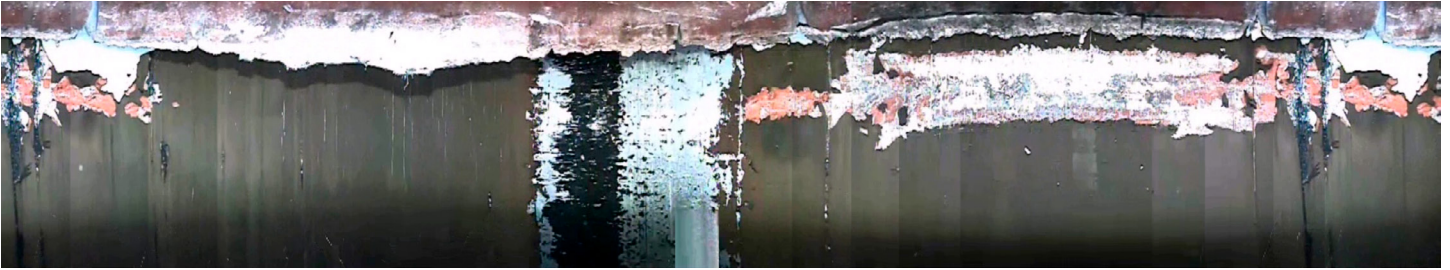
Figure 2: 360 degree stitched image providing a complete profile of the successful cut for clear and concise confirmation

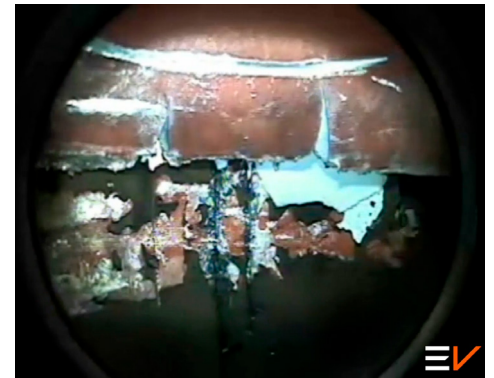
The sideview footage revealed the cut in more detail (**Fig.3**), showing no anomalies. By applying proprietary Visual Analytics processes, a 360 degree continuous image was generated, providing a complete profile of the successful cut for clear and concise confirmation (**Fig.2**). Less than 10 metres below, the tail pipe was located standing upright within the 11 ¾ inch casing. With this visual confirmation, the operator was able to proceed with an operation to cut the 11 ¾ inch casing.

Figure 3: Sideview image confirming clean 7 inch casing cut

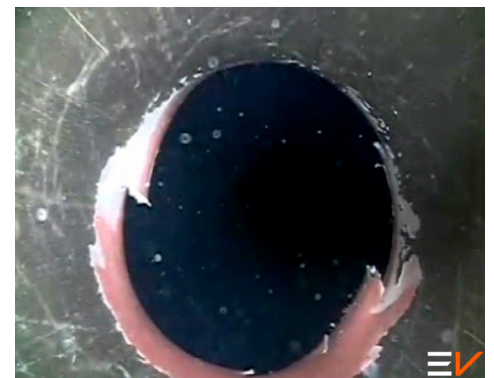
After cutting the 11 ¾ inch casing, the camera was run again to inspect the area. The real-time downview footage immediately revealed the successful casing cut (**Fig.4**), with the detailed sideview footage confirming a clean cut.

Figure 4: Downview image confirming 11 3/4 inch casing cut

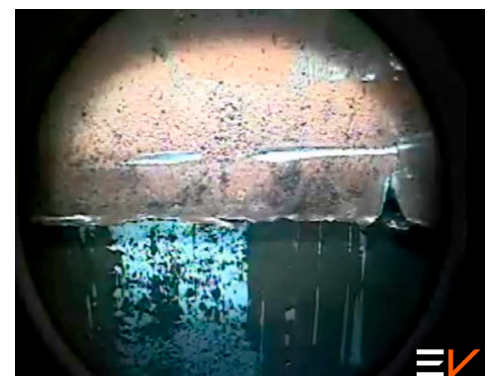
The final camera run confirmed the 7 inch casing cut, with the sideview footage confirming another successful cut (**Fig.5**). Upon running the camera deeper into the cavern, a clear passage to the bottom of the cavern was confirmed for the installation of a liner assembly.

Figure 5: Sideview image confirming final 7 inch casing cut

Finally, the operator installed a liner assembly at the bottom of the 7 inch casing, enabling successful restoration of efficient salt production.
