INSPECTION OF JET PUMP HOUSING

EV's Integrated Video Caliper (IVC) tool incorporates qualitative and quantitative measurements to assess wellbore corrosion.

PIN-HOLE IN JET PUMP HOUSING

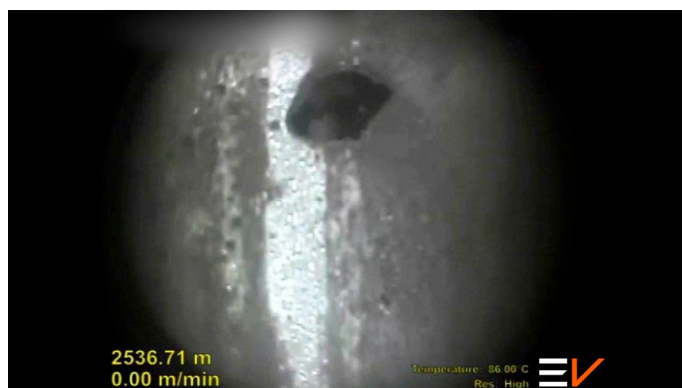
Figure 1: Sideview images of hole in Jet Pump Housing

Upon reaching the depth of interest, the sideview camera identified a hole in the jet pump housing, as initially suspected (**Fig.1**). The hole was accurately measured at the wellsite to evaluate the extent of the damage (**Fig.2**). The visual assessment was confirmed by the caliper data with a single arm deflection (**Fig.3**). A 360 inspection of the jet pump assembly also revealed a severe scaling issue, indicating the need for downhole chemical injection (**Fig.4**). With this knowledge, the operator was able to manufacture a modified jet pump solution which isolated the hole, thereby restoring full functionality, and deferring a multi-million dollar workover.

Upon reaching the depth of interest, the side view camera identified a hole in the Jet Pump housing, which confirmed the early suspicions (**Fig.1**). The Optis visualization and dimensioning software platform was used to accurately measure and quantify the size of the hole - immediately at the well site (**Fig.2**).

The information provided by the IVC confirmed the integrity issue was isolated to the jet pump assembly. With this knowledge, the operator was able to manufacture a modified jet pump solution that isolated the hole. By changing the paths of power fluids and formation fluids, the operator managed to eliminate the differential pressure across the hole and recover the full functionality of the jet pump hydraulics, deferring a multi-million dollar workover.

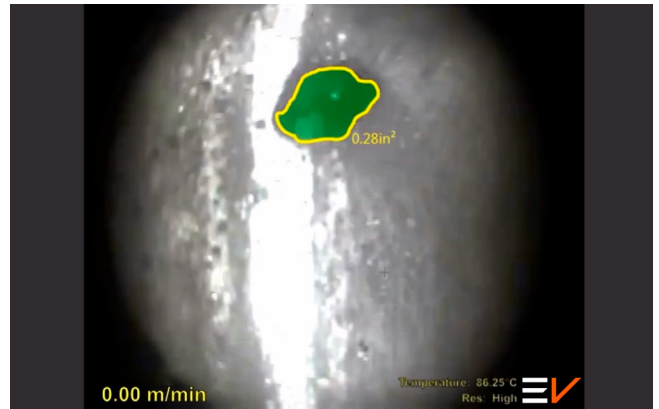
Figure 2: Dimensioned hole revealing the extent of damage

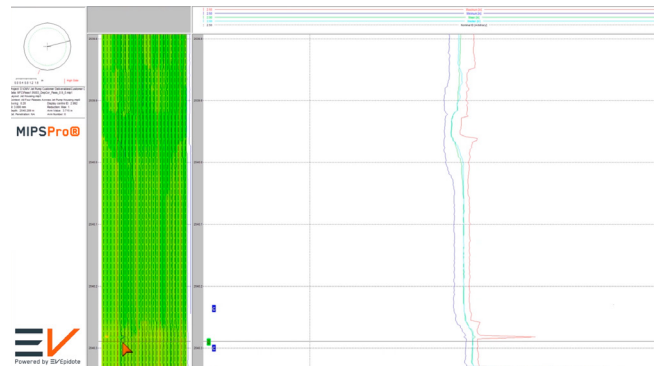
The visual assessment was confirmed by the multi-finger caliper data, with a single arm deflection (**Fig.3**).

Figure 3: Single arm deflection revealed in caliper data

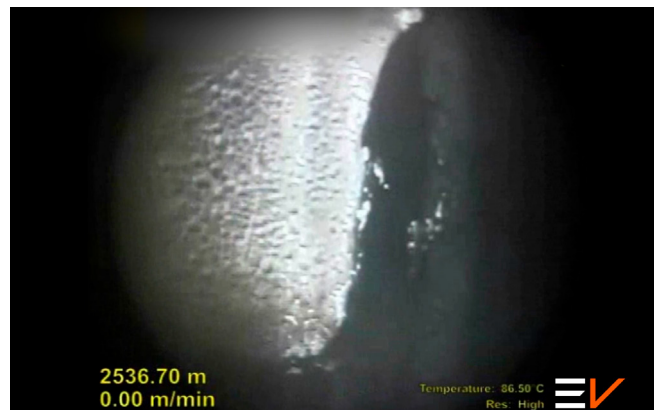
The 360 degree inspection of the jet pump assembly identified further anomalies with the jet pump housing, with both the downview and sideview cameras revealing a severe scaling issue, indicating a need for downhole chemical injection (**Fig.4**).

Figure 4: Sideview images revealing severe scaling issue
