TROUBLESOME STRADDLE PACKER RETRIEVED

EV's memory camera provides valuable insight and visual data to assist with complex fishing operations

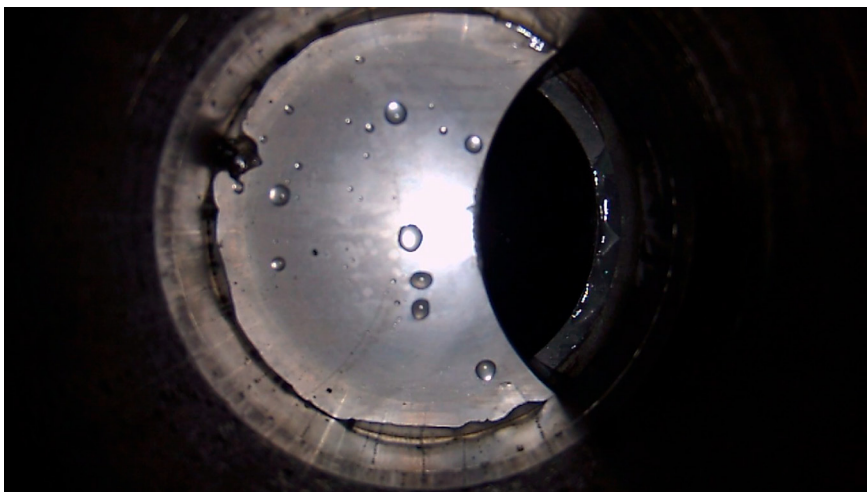
The camera was run to the top of the Christmas tree where the downview camera showed the gate valve to be clean and functioning well (**Fig. 1**).

Figure 1: Downview image of Gate Valve

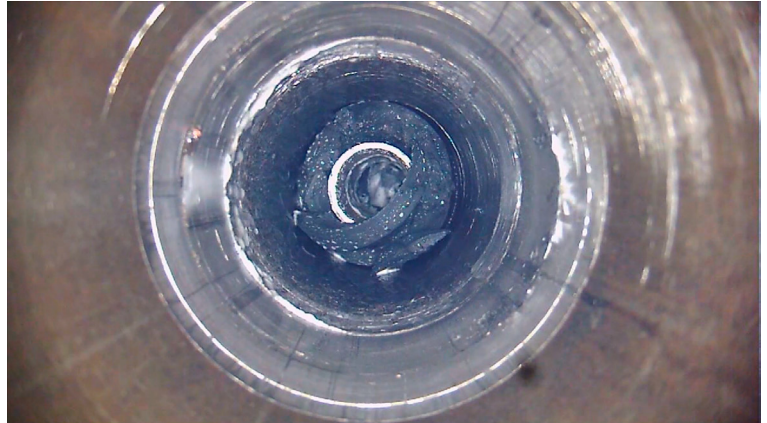
Immediately below the gate valve, the downview camera revealed the location of the stuck straddle packer, and that fragments of the rubber sealing element appeared to have broken away from the straddle packer assembly (**Fig.2**).

Figure 2: Location of Stuck Straddle Packer

With visual confirmation of fish location and status attained, and a clear understanding of the problem provided, the operator was able to design a customised fishing tool, which successfully retrieved the fish on the next run, thereby restoring the well.

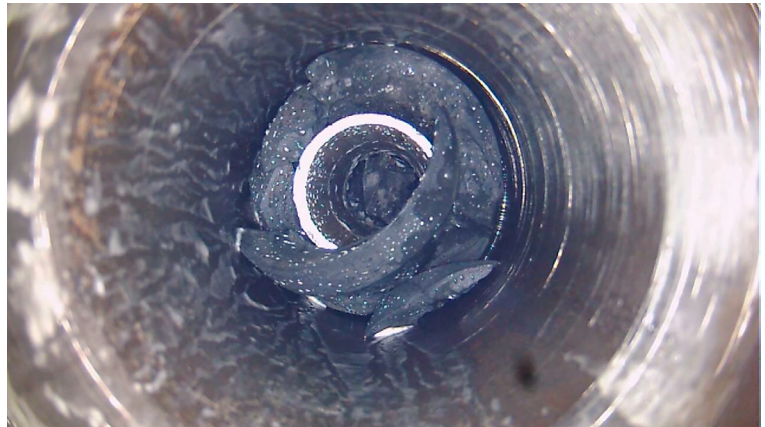
It was suspected that the rubber seal fragments located on top of the straddle packer mandrel were preventing the fishing tool from engaging correctly and were responsible for the multiple failed fishing attempts. (**Fig.3**).

Figure 3: Rubber Seal Fragments Preventing Fishing Attempts
