Optis Technology

PINPOINTING & ISOLATING WATER ENTRY IN A GAS WELL

EV's real-time camera provides valuable insight and live visual data to assist with water entry detection

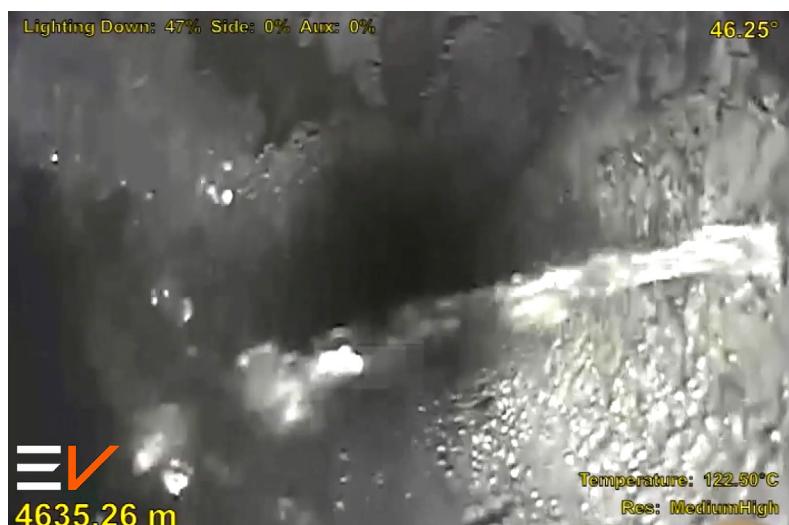
Figure 1: Pin-pointing water entry from a perforation

Upon reaching 4600m depth, the camera revealed severe scale build-up (**Fig.2**), in addition to the presence of water. As the camera continued to descend, the perforations producing water could easily be seen with flow increasing throughout the stage (**Fig.1**).

With this single intervention confirming the presence and pinpointing the location of water entry, the operator was able to install a straddle isolation system over the water producing zone, thus eliminating the water at source and restoring profitable hydrocarbon production once again (**Fig.3**).
